CORNER FILE TRACKING

CORNER NUMBER
105300540

BENTON COUNTY CORNER RESTORATION FORM, PAGE 1 OF 2, 105300540R2

TOWNSHIP 10 SOUTH, RANGE 5 WEST, WILLAMETTE MERIDIAN; SECTION 8 CORNER EAST 1/4

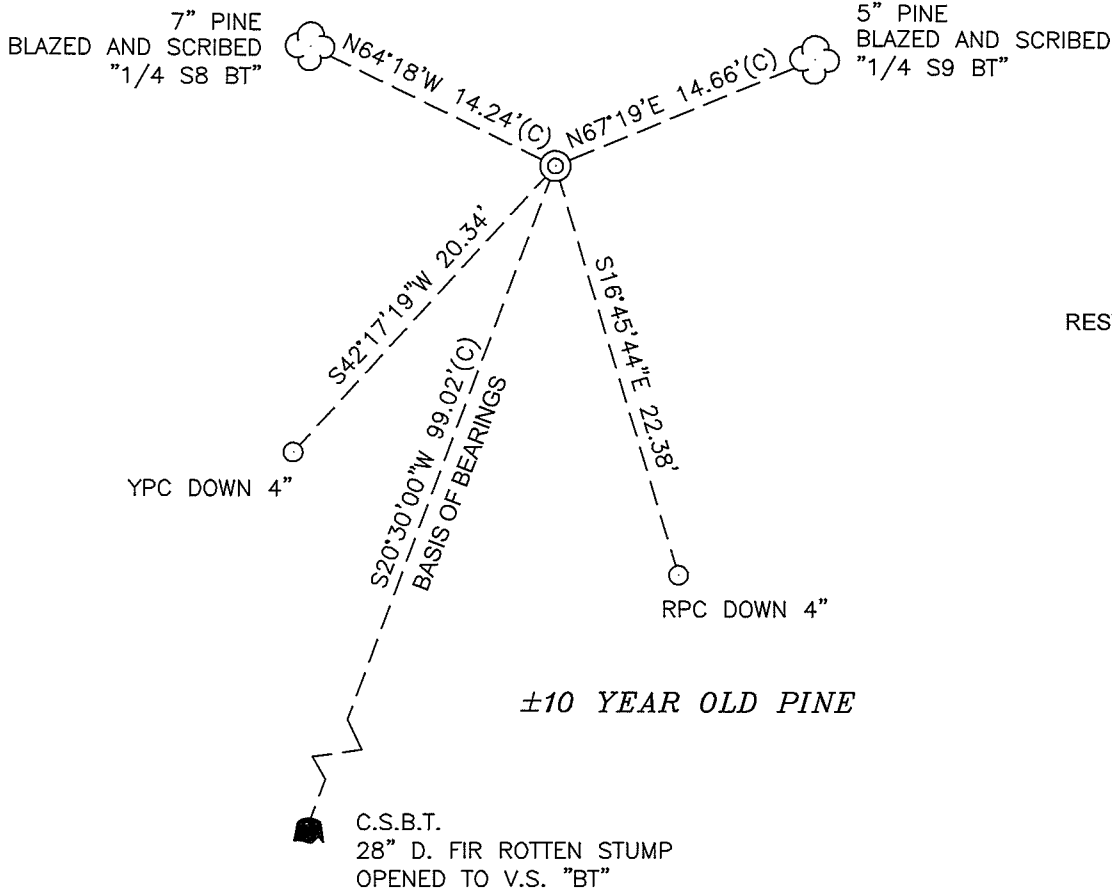
1. FOUND 1-1/4" X 16" INNER DIAMETER GALVANIZED IRON PIPE WITH FLARED TOP, FIRMLY SET, 12" BELOW GROUND SURFACE.
(SET POST PER RECORD [01]).
(SET 1-1/4" GALV. PIPE 18" LONG 12" UNDER SURFACE PER RECORD [02]).
(SET A 1-1/4" PIPE 12" UNDER SURFACE PER RECORD [03]).
(1/4" PIPE 12" UNDER SURFACE PER RECORDS [05] AND [06]).
(FOUND 1-1/4" PIPE 1 FOOT UNDER GROUND SURFACE PER RECORD [07]).
2. FOUND ROTTEN D. FIR STUMP 28" DIA BEARS S20°30'00"W, 99.02 FEET TO CENTER. OPENED TO VISIBLE SCRIBING "BT".
BASIS OF BEARINGS FOR THIS RESTORATION.
(FIR 15" DIA BEARS S20-1/2°W, 1.499 CHAINS +3° [98.80 FEET] PER RECORD [02]).
(FIR 15" DIA BEARS S20°30'W, 1.499 CHAINS [98.93 FEET] PER RECORD [03]).
(FIR 15" DIA BEARS S20-1/2°W, 1.49 CHAINS [98.34 FEET] PER RECORD [05]).
(FIR 15" DIA BEARS S20°W, 1.49 CHAINS [98.34 FEET] PER RECORD [06]).

FOUND 1-1/4" X 16" GALVANIZED IRON PIPE WITH FLARED TOP, FIRMLY SET, 12" BELOW GROUND SURFACE FOR THE CORNER. THE PIPE WAS SET BY W. C. GALLOWAY, C.S., IN 1930, AS A PERPETUATION OF THE CORNER FROM BOTH GLO BEARING TREES. I HELD THE PIPE AS THE PERPETUATION OF THE CORNER POSITION.

REMOVED THE 1-1/4" IRON PIPE AND IN THE SAME HORIZONTAL POSITION SET A 2" X 31-1/2" GALVANIZED IRON PIPE WITH A 3-1/4" BRASS DISK CEMENTED IN THE TOP, 7" BELOW GROUND SURFACE AND MARKED AS SHOWN ON PAGE 2 OF 2. BURIED THE 1-1/4" IRON PIPE HORIZONTALLY ON THE EAST SIDE OF THE NEW MONUMENT. SET TWO NEW IRON ROD ACCESSORIES AND BLAZED AND SCRIBED TWO NEW BEARING TREES AS SHOWN ON PAGE 2 OF 2. SET A 6 FOOT ORANGE CARSONITE "SURVEY MARKER" POST 1 FOOT EAST OF NEW MONUMENT.

1. SET REBAR (SEE LEGEND) S16°45'44"E, 22.38 FEET AND 4 INCHES BELOW GROUND LEVEL.
2. SET REBAR (SEE LEGEND) S42°17'19"W, 20.34 FEET AND 4 INCHES BELOW GROUND LEVEL.
3. PINE 5" DIA BEARS N67°19'E, 14.66 FEET TO CENTER, FACE SCRIBED "1/4 S9 BT". SET ALUMINUM NAIL AND PLASTIC WASHER ON NORTHWESTERLY BASE FOR DISTANCE MEASUREMENT.
4. PINE 7" DIA BEARS N64°18'W, 14.24 FEET TO CENTER, FACE SCRIBED "1/4 S8 BT". SET ALUMINUM NAIL AND PLASTIC WASHER ON NORTHEASTERLY BASE FOR DISTANCE MEASUREMENT.

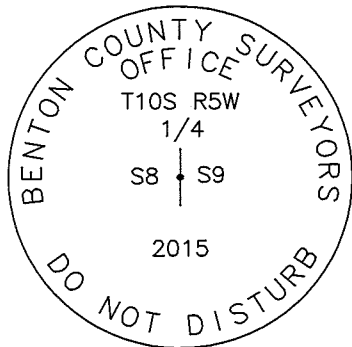
MONUMENT DETAIL

3-1/4" BRASS DISK

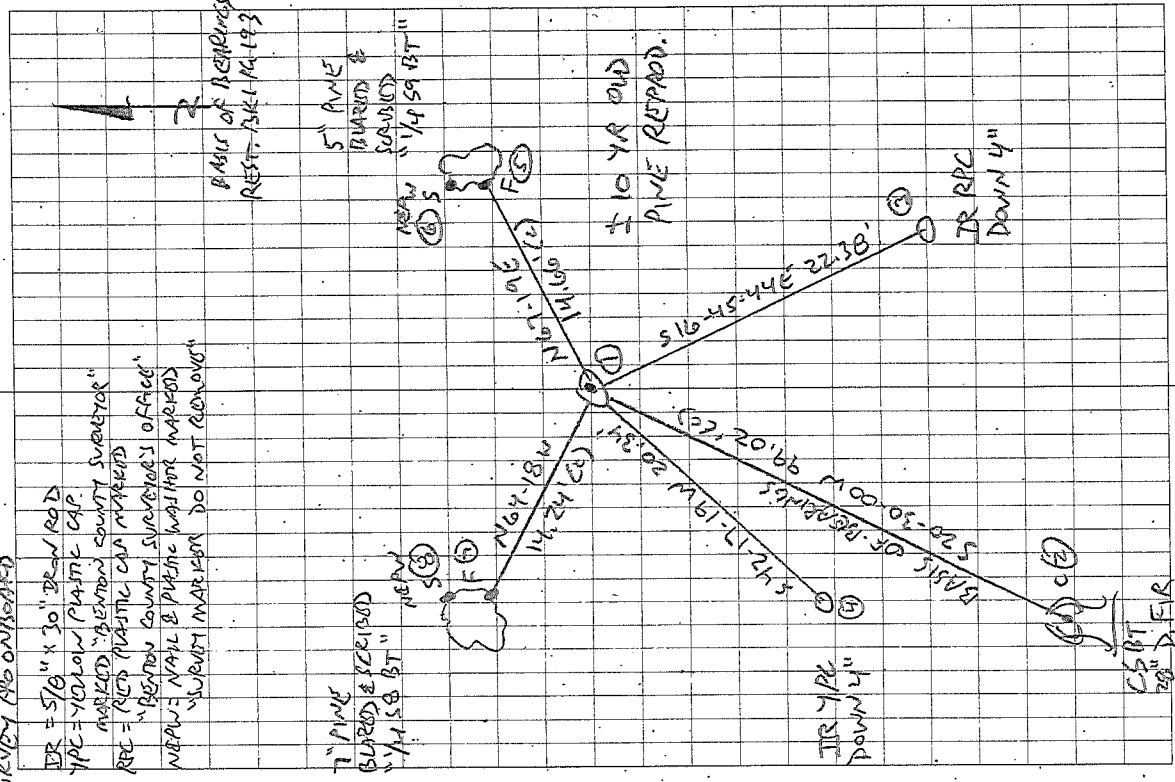
CSBT
 28" D. FIR
 ROTTEN STUMP
 OPENED TO U.S. "BT"

FD 1-1/4" IRON PIPE x 16" LONG, FIRMLY SET TOP FLARED,
 12" BELOW GROUND SURFACE. REMOVED 1-1/4" PIPE
 AND IN SAME HORIZONTAL POSITION SET A 2" x 3-1/4"
 G.I.P. W/ 3-1/4" BRASS DISK CEMENTED IN THE TOP,
 7" BELOW GROUND SURFACE, FD SW CSBT STUMP AND
 HELD FOR BASIS OF BEARINGS. FD POSSIBLY SE CSBT
 STUMP, ROTTEN AND UPROOTED, PARTIALLY SUBMERGED IN
 STREAM, FD POSSIBLE NW 6/8 BT, DOWN, ROTTEN, AND BURNT.
 NO VISIBLE MARKS OR APPARENT ROOT HOLES. SET
 2 NEW IRON ROD ACCESSORIES AND BURIED & SCRIBED
 2 NEW BEARING TREES. BURIED 1-1/4" PIPE HORIZONTALLY
 ON EAST SIDE OF BRASS DISK, SET 6" ORANGE CARBONITE
 "SURVEY MARKER" POST 1' EAST OF NEW MONUMENT.

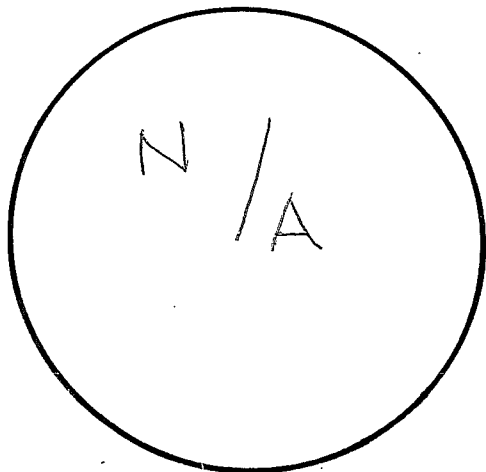
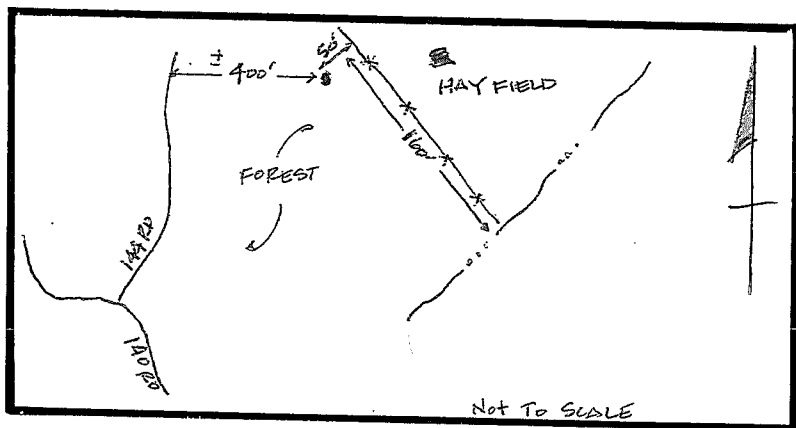
FOUND: 1 1/4" PIPE 1' UNDER GROUND SURFACE,
FOUND: 1 20" DOUGLAS FIR WITH CORNER LOCATION
POSTER, BT IS S 40° W, 4.0', FROM MONUMENT

MONUMENT FOUND IN GOOD CONDITION
BEARING TREE FOUND IN GOOD CONDITION WITH
CORNER LOCATION POSTER INTACT
