POLK COUNTY CORNER RESTORATION FORM

SECTION 11 TOWNSHIP 10 S RANGE 5 W W.M. BLM ID 539565

DLC _____ CORNER County Line Monument

DATE 4/15/2011 CORNER RESTORATION FIELD BOOK 200-12 PAGE 5

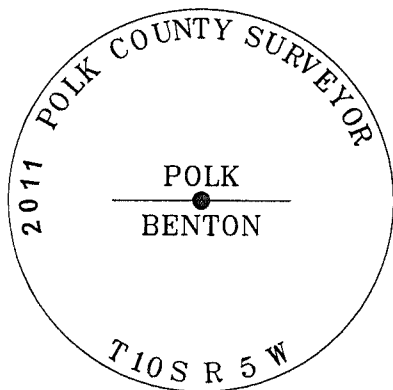
MONUMENT DETAIL

I found a 3/4" iron pipe cited by BCS 134 as being on the County Line. The iron pipe has a 5/8" iron rod driven inside it and the iron rod is down 6". A typical concrete County Line monument bears east 29'. The concrete monument is broken off at the base with the top of the monument laying beside the base. Note: DeArmond/Robison Rds. were relocated after the iron pipe and concrete monument were set. The angle point in DeArmond/Robison Rds. is now 700' easterly of the County Line Monument.

I drove a 2" X 30" iron pipe with 2 1/2" brass cap over the found iron pipe. The cap is up 6".
