CORNER FILE TRACKING

CORNER NUMBER
105300540

BENTON COUNTY CORNER RESTORATION FORM, PAGE 1 OF 2, 105300540R2

TOWNSHIP 10 SOUTH, RANGE 5 WEST, WILLAMETTE MERIDIAN; SECTION 8 CORNER EAST 1/4

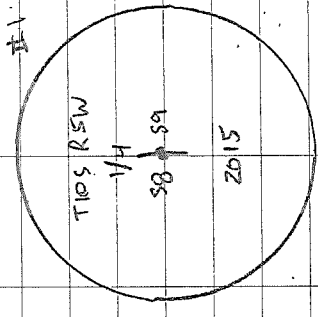
FD 1-1/4" IRON PIPE x 16" LONG, FIRMLY SET TOP FLARED,
 12" BELOW GROUND SURFACE. REMOVED 1-1/4" PIPE
 AND IN SAME HORIZONTAL POSITION SET A 2" x 3-1/4"
 G.I.P. W/ 3-1/4" BRASS DISK CEMENTED IN THE TOP,
 7" BELOW GROUND SURFACE, FD SW CSBT STUMP AND
 HELD FOR BASIS OF BEARINGS. FD POSSIBLY SE CSBT
 STUMP, ROTTEN AND UPROOTED, PARTIALLY SUBMERGED IN
 STREAM, FD POSSIBLE NW 6/8 BT, DOWN, ROTTEN, AND BURNT.
 NO VISIBLE MARKS OR APPARENT ROOT HOLES. SET
 2 NEW IRON ROD ACCESSORIES AND BURIED & SCRIBED
 2 NEW BEARING TREES. BURIED 1-1/4" PIPE HORIZONTALLY
 ON EAST SIDE OF BRASS DISK, SET 6" ORANGE CARBONITE
 "SURVEY MARKER" POST 1' EAST OF NEW MONUMENT.
