RECORD OF SURVEY

for **STARKER FORESTS, INC.**

in the NE1/4 SECTION 23, T10S, R6W, W.M.

BENTON COUNTY, OREGON

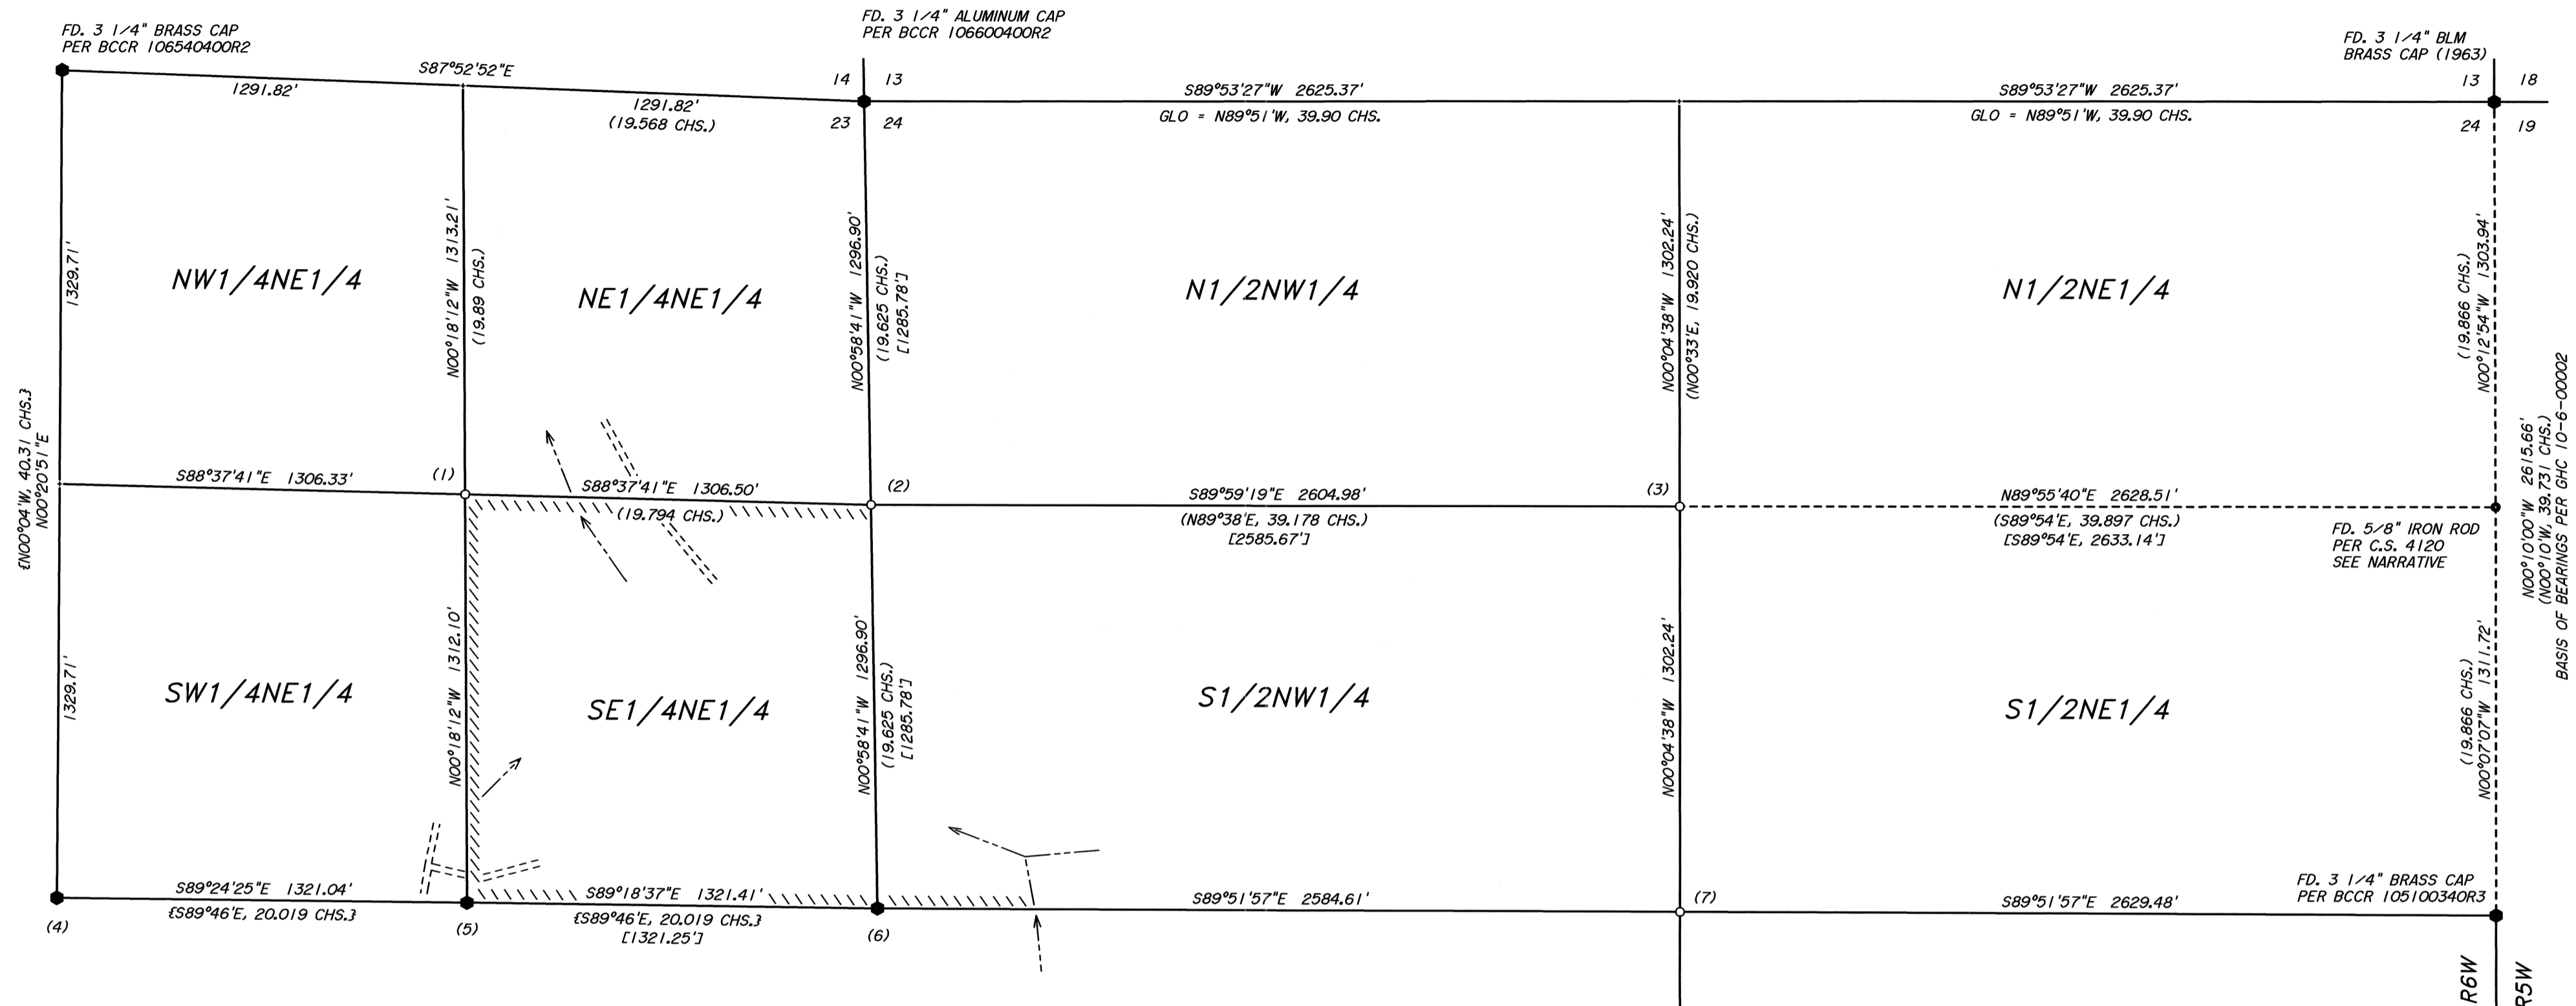
- Monuments found as noted
- Monuments set as noted
- () Data of record per GHC 10-6-00002
- £ } Data of record per GHC 10-6-00004
- [] Data of record per C.S. 4120
- \\\\\\ Boundary lines posted with 6' fiberglass posts, blue painted blazes, and blue flagging
- ===== Approximate road location
- Approximate creek centerline
- BT distances measured are to center of tree
- Iron pipe diameters are inside measure

The purpose of this survey is to establish the corners of the SE1/4 of the NE1/4 of Section 23, and the S1/2 of the NW1/4 of Section 24. We also marked the indicated boundary lines.

GHC 10-6-00004 subdivided Section 23, and established the C1/4 and CE1/16 corners. Said survey also perpetuated the 1/4 corner of Sections 23 and 24.

GHC 10-6-00002 partially subdivided the N1/2 of Section 24. Said survey perpetuated the NW, N1/4, NE, and E1/4 corners of Section 24. Said survey also established the N1/16 corner on the East line of Section 24, and a position intended to be the CN1/16 corner of Section 24.

Since we did not recover the N1/4 corner of Section 24, and GHC 10-6-00002 did not provide enough data to reestablish said corner, we were left with no choice other than to compute said corner point at a proportionate position. We then completed the subdivision of Section 24, and set the CN1/16 and C1/4 corners of Section 24.

Monuments found as per GHC 10-6-00002, GHC 10-6-00004, GHC 10-6-00012, C.S. 4120, 1963 BLM Resurvey, BCCR Book 1, Page 170, BCCR Book 1, Page 186, BCCR 106540400R2, BCCR 105100340R3, and BCCR 106600400R2 were held as control for this survey.
