RECORD OF SURVEY
for **STARKER FORESTS, INC.**
in SECTION 9, T12S, R7W, W.M.
BENTON COUNTY, OREGON
JANUARY 13, 2012

SURVEYED BY:
PETERSON & ASSOCIATES
8155 NW MITCHEL DRIVE
CORVALLIS, OREGON 97330
PHONE: 541-757-1794

C.S. FILE NO. 10524
FILING DATE 2-15-12
FILE SIZE 18x24

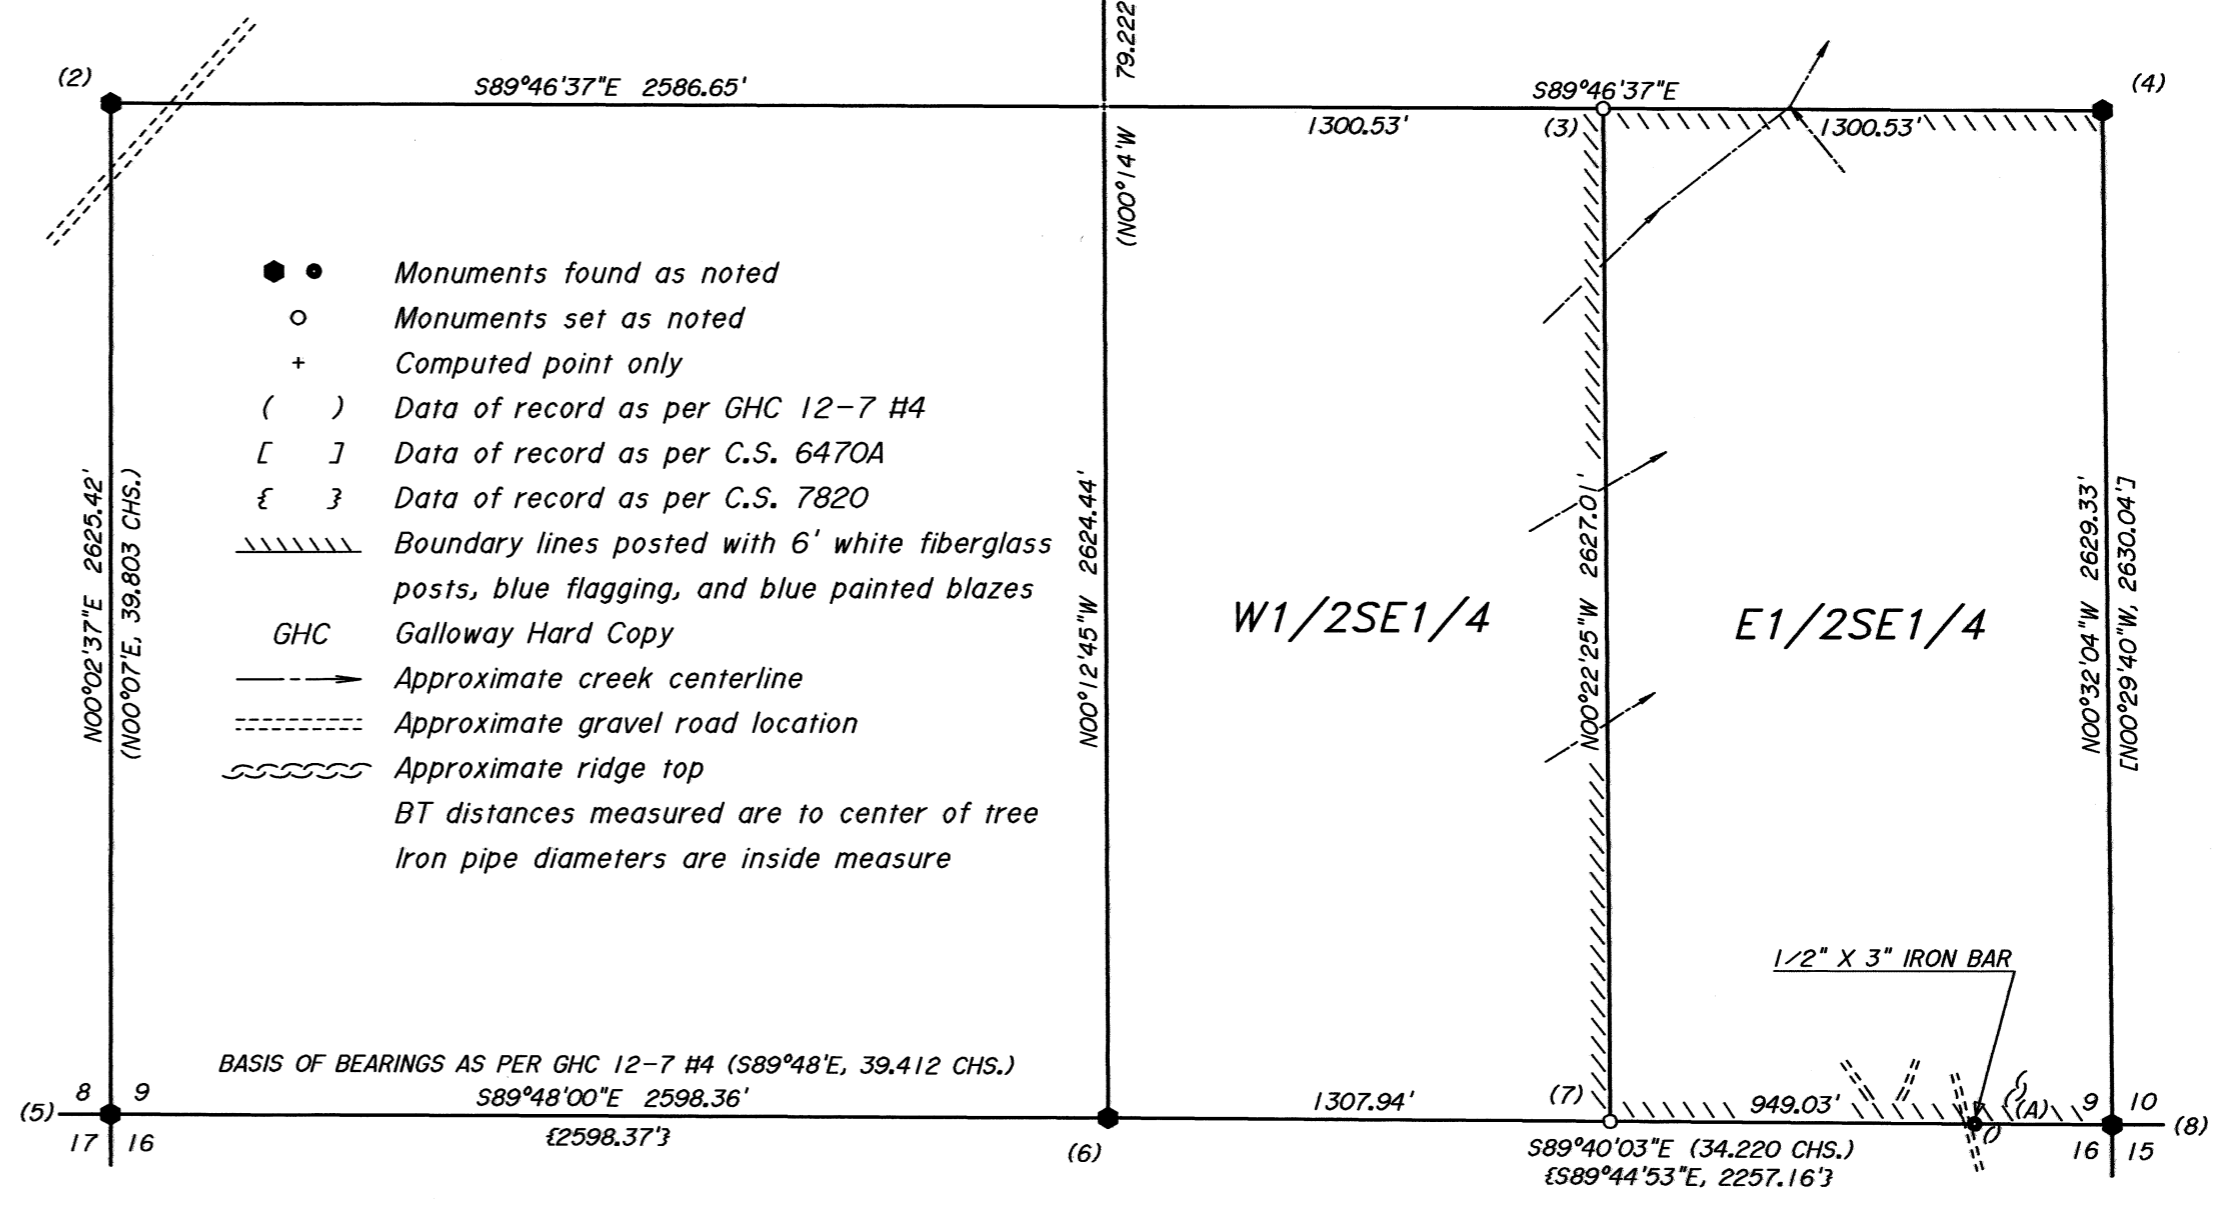
The purpose of this survey is to subdivide Section 9 in order to establish the CE1/16 corner of Section 9 and the E1/16 corner of Sections 9 and 16. We also marked the indicated boundary lines.

Monuments found per GHC 12-7 H4, C.S. 6470A, and C.S. 7820 were held as control for this survey.

The West 1/4 corner of Section 9 was reestablished by GHC 12-7 H4 by single proportion. At this corner we found both BT's as uproots. The pipe had been pulled out of the ground by the Northeast BT uproot. Since the Northwest BT uproot was further away than the Northeast BT uproot, and on a steep hillside with a large uproot hole, we reset this corner from the Northeast BT only.

At the CE1/16 corner we found the monument set by C.S. 6470A to be very close to the true corner position. However, since that monument had not been set by a true section subdivision, we set a new monument at the true corner.
