SURVEYOR'S NARRATIVE:

THE PURPOSE OF THIS SURVEY IS TO ESTABLISH THE BOUNDARY OF PARCEL 1 OF PARTITION PLAT 94-42 AND TO RETRACE THE MEETS AND BOUNDS OF PARCEL II AS DESCRIBED IN DEED RECORD M-85348-86 TOGETHER WITH THE TRUAX OIL TRACT DESCRIBED IN DEED RECORD M-85348-96 LOCATED IN THE NORTHWEST 1/4 OF SECTION 35, TOWNSHIP 11 SOUTH, RANGE 5 WEST, WILLAMETTE MERIDIAN IN THE CITY OF CORVALLIS, OREGON.

BOUNDARY SURVEY FOR LEADERSHIP CIRCLE, LLC LOCATED IN NW 1/4 SEC 35, T11S, R5W, W.M. CITY OF CORVALLIS BENTON COUNTY, OREGON APRIL 3, 2013

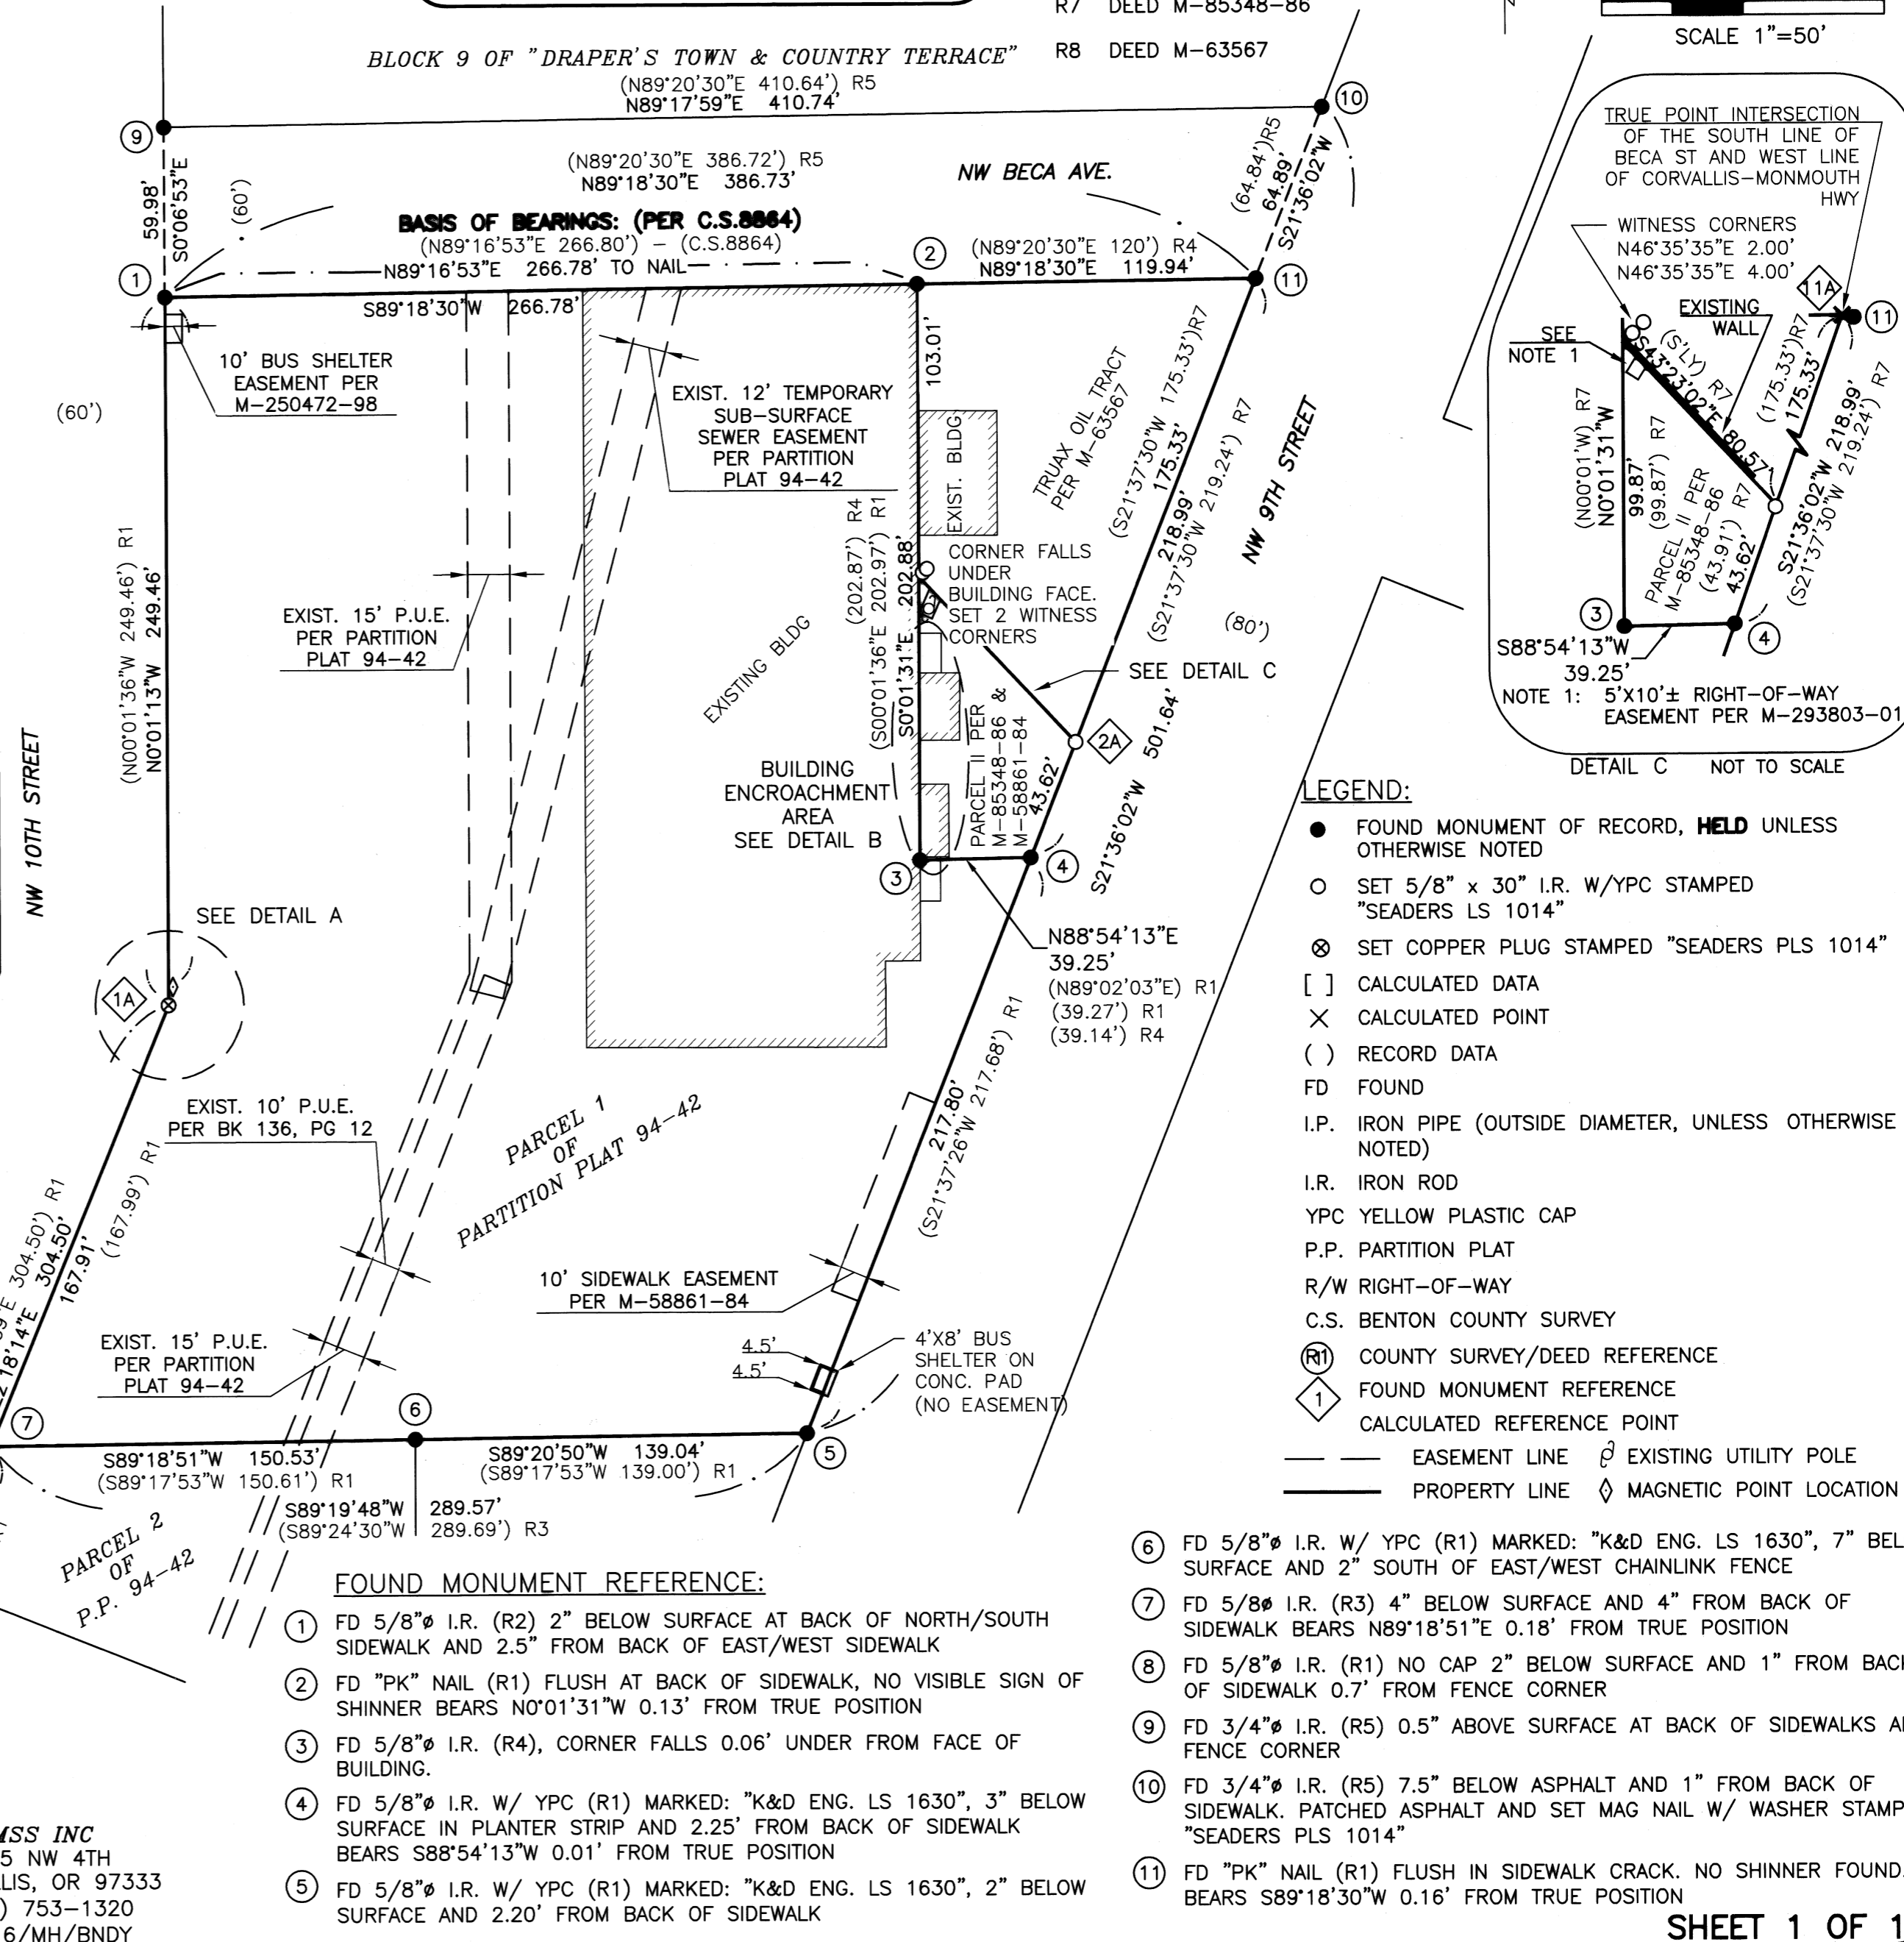
THE BASIS OF BEARING WAS ESTABLISHED BY HOLDING FOUND MONUMENTS (1) AND (2) PER C.S. 8864 AS SHOWN ON MAP.

POINT (1) AND (11) WERE HELD FOR THE SOUTH R/W OF NW BECA AVE. POINT (1) IS AN ORIGINAL MONUMENT AND IN GOOD CONDITION. POINT (11) IS A "PK" NAIL WITH A SHINER SET PER C.S. 8864. NO EVIDENCE OF SHINER WAS FOUND. BASED ON POINT (10), MAGNETIC POSITION PROPAGATED BY PK AT POINT (11) DOES NOT APPEAR TO PROVIDE THE BEST EVIDENCE OF ORIGINAL LOCATION. THE LOCATION OF NAIL FITS WELL WITH RECORD AND WAS HELD FOR BECA AVE. R/W BUT NOT 9TH ST. R/W. POINT (2) IS A "PK" NAIL WITH A SHINER SET PER C.S. 8864. NO EVIDENCE OF SHINER WAS FOUND. THE LOCATION OF POINT (2) FITS WELL FOR POSITION FROM POINT (1) BUT IS NORTH 0.10' FROM BECA AVE. R/W AND WAS HELD FOR THE EAST LINE OF PARCEL 1 BUT NOT FOR BECA AVE. R/W.

POINT (3) WAS HELD AND IS A 5/8" IRON ROD SET PER C.S. 2670. C.S. 4167 SETS AN IRON ROD 0.05' EAST OF BUILDING. NO EVIDENCE WAS FOUND FOR TWO RODS. AN EXTERIOR WALL TREATMENT HAS BEEN INSTALLED TO EXISTING BUILDING AND AS A RESULT THE CORNER LAY UNDER THE BUILDING APPROXIMATELY 0.06'.

POINT (5) WAS ORIGINALLY SET PER C.S. 4155. C.S. 8864 NOTES FINDING A 5/8" IRON ROD AND BEING OFF BY 0.04' FROM TRUE POSITION, HOWEVER THE SYMBOL INDICATES CORNER WAS SET. FOUND POINT IS A 5/8" IRON ROD WITH YPC MARKED AS INDICATED BY THE SURVEY. NO OTHER RODS WERE FOUND AND THERE IS NO REFERENCE OF THIS POINT BEING RE-ESTABLISHED WITH HIS CAP. THE LOCATION OF ROD FITS WELL FOR POSITION AND WAS HELD. POINT (10) IS UNDER ASPHALT AND THE ASPHALT WAS REMOVED IN ORDER TO TIE THE CORNER. MONUMENT IS AN ORIGINAL CORNER IN GOOD CONDITION AND WAS HELD FOR 9TH ST. R/W. THE ASPHALT WAS REPLACED AND A MAG NAIL W/ WASHER WAS SET OVER THE CORNER. POINT (4) IS WEST 0.01' FROM 9TH ST. R/W. THE LOCATION OF ROD FITS WELL FOR POSITION FROM POINT (3) AND WAS HELD FOR BOUNDARY CORNER OF PARCEL 1. POINT (11) IS EAST 0.15' FROM 9TH ST. R/W BUT HELD FOR BECA AVE. R/W AS NOTED ABOVE. THE TRUE POSITION SHOWN AS POINT <11A> WAS CALCULATED BY INTERSECTING LINE (1) - (11) WITH (5) - (10). I USED RECORD DISTANCE 175.33' SOUTHERLY PER DEED M-85348-86 FROM POINT <11A> ALONG THE WEST R/W LINE OF 9TH ST. TO ESTABLISH THE NORTHEAST CORNER OF PARCEL II OF SAID DEED AND SHOWN AS POINT <2A> ON MAP.

THE EAST R/W OF NW 10TH ST. WAS ESTABLISHED BY HOLDING FOUND MONUMENTS SHOWN AS POINT (1) AND (8). I USED DISTANCE DISTANCE INTERSECT USING RECORD DISTANCES PER C.S. 8864 TO ESTABLISH THE ANGLE POINT IN R/W SHOWN AS POINT <1A>. THE CORNER FALLS IN THE PARKING LOT AS NOTED IN C.S. 8864. A CONCRETE APRON WAS CONSTRUCTED AT THE DRIVEWAY ENTRANCE AND THE ORIGINAL CORNER HAS EITHER BEEN DESTROYED OR DISTURBED DURING THE CONSTRUCTION PROCESS. A MAGNETIC DETECTOR INDICATES A GOOD SIGNAL IN THE SEARCH AREA SHOWING THAT THE CORNER MAY EXIST BUT HAS BEEN DISTURBED. THE RELATIONSHIP BETWEEN THE MAGNETIC SIGNAL WITH THE CALCULATED POSITION ARE SHOWN ON MAP. POINTS (1) AND (8) FIT WELL BASED ON RECORD BEARINGS AND DISTANCES. POINT (7) IS EAST 0.18' FROM 10TH ST. R/W. ALTHOUGH NO VISIBLE EVIDENCE OF DISTURBANCE EXIST, POINT (7) DOES NOT APPEAR TO PROVIDE A GOOD FIT WITH ADJACENT MONUMENTS AND RECORD BEARINGS AND DISTANCES. CONSTRUCTION OF A WALL AND UNDERGROUND UTILITIES IN THIS AREA MAY HAVE DISTURBED THE MONUMENT. POINT WAS HELD FOR THE SOUTH BOUNDARY LINE OF PARCEL 1 BUT NOT FOR 10TH ST R/W.

THE EXISTING BUILDING ON PARCEL 1 OF PARTITION PLAT 94-42 ENCROACHES ALONG THE EAST PROPERTY LINE. PERMIT BLD01-01105 INDICATES IMPROVEMENTS AND AN ADDITION OF FACADES TO THE EXISTING BUILDING WERE CONSTRUCTED AFTER THE PARTITION PLAT. THERE IS AN EXISTING BUILDING ON THE ADJACENT PROPERTY. THE WALLS OF EITHER BUILDING DO NOT ENCROACH ALONG THAT PORTION OF THE PROPERTY LINE, HOWEVER THE ROOFS ARE CONNECTED TO EACH OTHER. ENCROACHMENTS HAVE BEEN DIMENSIONED AS SHOWN AND MEASUREMENTS ARE FROM BUILDING FACE TO PROPERTY LINE.

- ⑪ FD "PK" NAIL (R1) FLUSH IN SIDEWALK CRACK. NO SHINER FOUND. BEARS S89°18'30"W 0.16' FROM TRUE POSITION
