U.S. FOREST SERVICE

CHINTIMINI PARK CADASTRAL SURVEY

SIUSLAW NATIONAL FOREST Contract No. 53-04TO-3-0849N

SECTIONS 17, 19, 20, 21 & 29, T.12S., R.7W., W.M., BENTON COUNTY, OREGON
NOV. 1, 1983

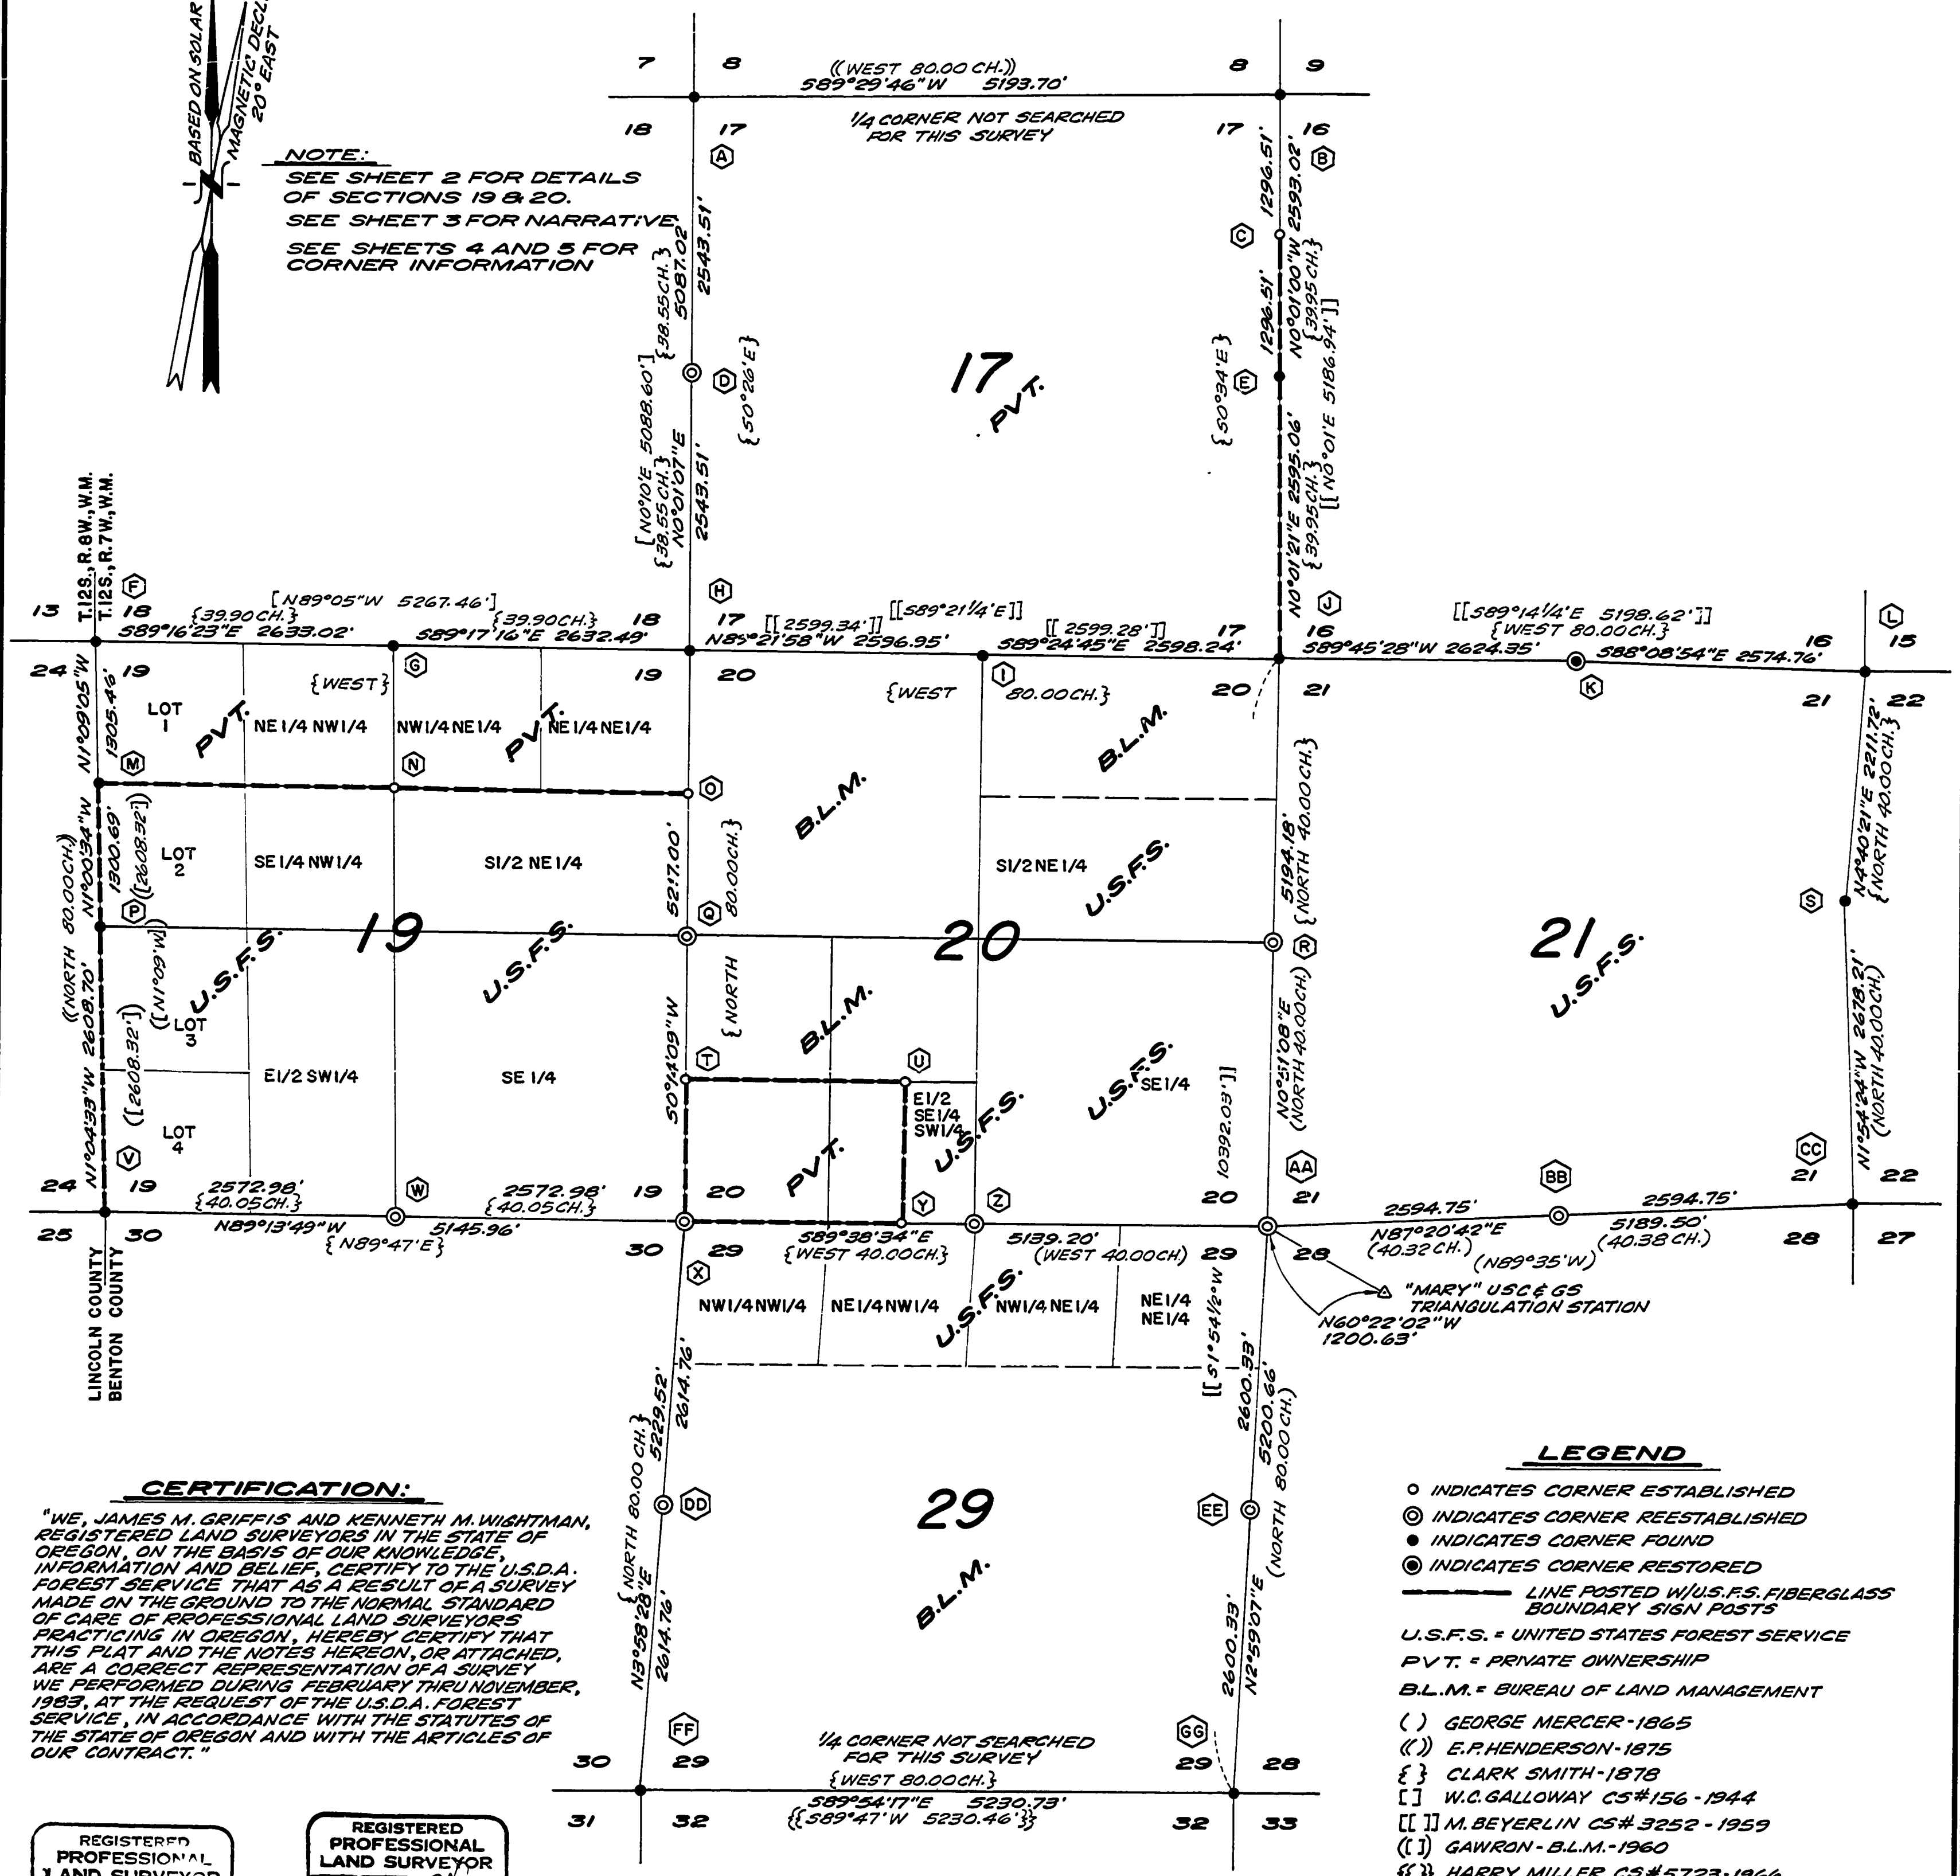
Pg. 1 of 5
7688

NOTE:
SEE SHEET 2 FOR DETAILS OF SECTIONS 19 & 20.
SEE SHEET 3 FOR NARRATIVE.
SEE SHEETS 4 AND 5 FOR CORNER INFORMATION

- LEGEND**
- INDICATES CORNER ESTABLISHED
 - ⊙ INDICATES CORNER REESTABLISHED
 - INDICATES CORNER FOUND
 - ⊕ INDICATES CORNER RESTORED
 - LINE POSTED W/ U.S.F.S. FIBERGLASS BOUNDARY SIGN POSTS
 - U.S.F.S. = UNITED STATES FOREST SERVICE
 - P.V.T. = PRIVATE OWNERSHIP
 - B.L.M. = BUREAU OF LAND MANAGEMENT
 - () GEORGE MERCER - 1865
 - (¹) E.P. HENDERSON - 1875
 - { } CLARK SMITH - 1878
 - [] W.C. GALLOWAY CS# 156 - 1944
 - [] M. BEYERLIN CS# 3252 - 1959
 - (¹) GAWRON - B.L.M. - 1960
 - { } HARRY MILLER CS# 5723 - 1966
 - ALL PIPE SIZES INDICATED ARE INSIDE DIAMETER

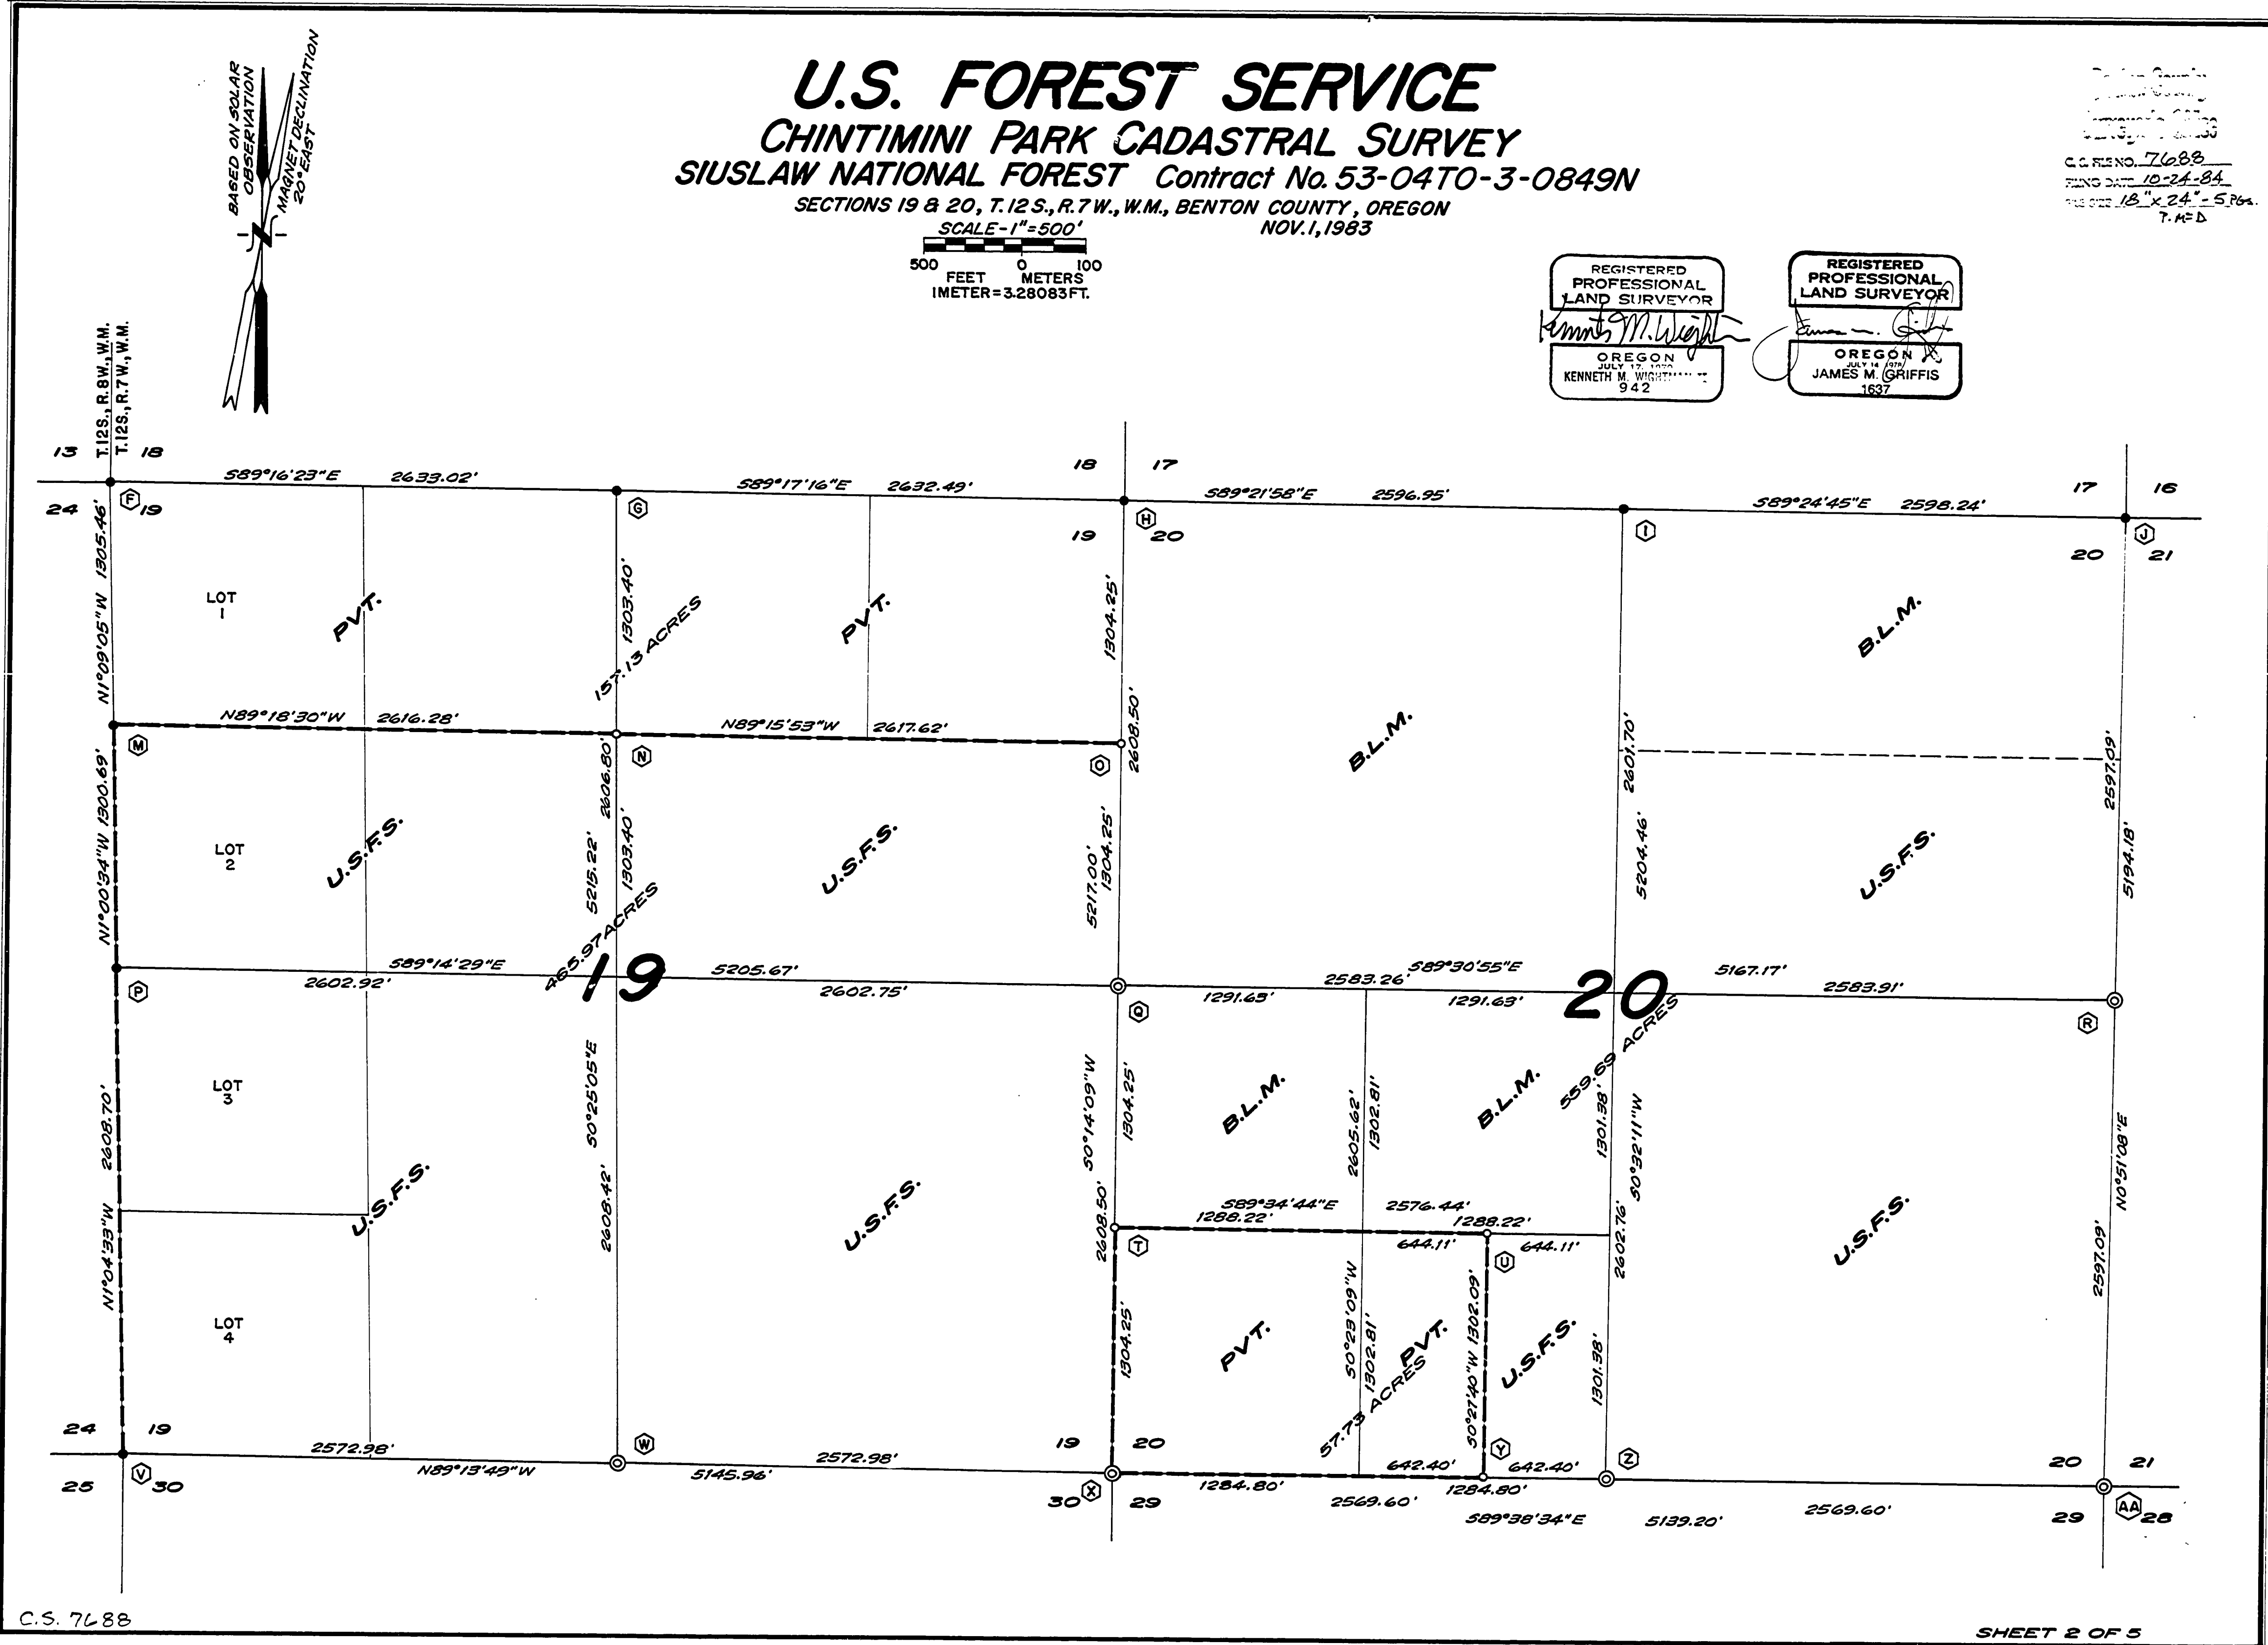
7688 Pg 2 OF 5

U.S. FOREST SERVICE
CHINTIMINI PARK CADASTRAL SURVEY
SIUSLAW NATIONAL FOREST Contract No. 53-04T0-3-0849N
 SECTIONS 19 & 20, T.12S., R.7W., W.M., BENTON COUNTY, OREGON
 NOV. 1, 1983
