RECORD OF SURVEY
for STARKER FORESTS, INC.
in SECTION 6, T13S, R6W, W.M.
BENTON COUNTY, OREGON
MARCH 13, 1990

CS file # 8392
FILING DATE 3/30/1990
FILE SIZE 18" X 24"

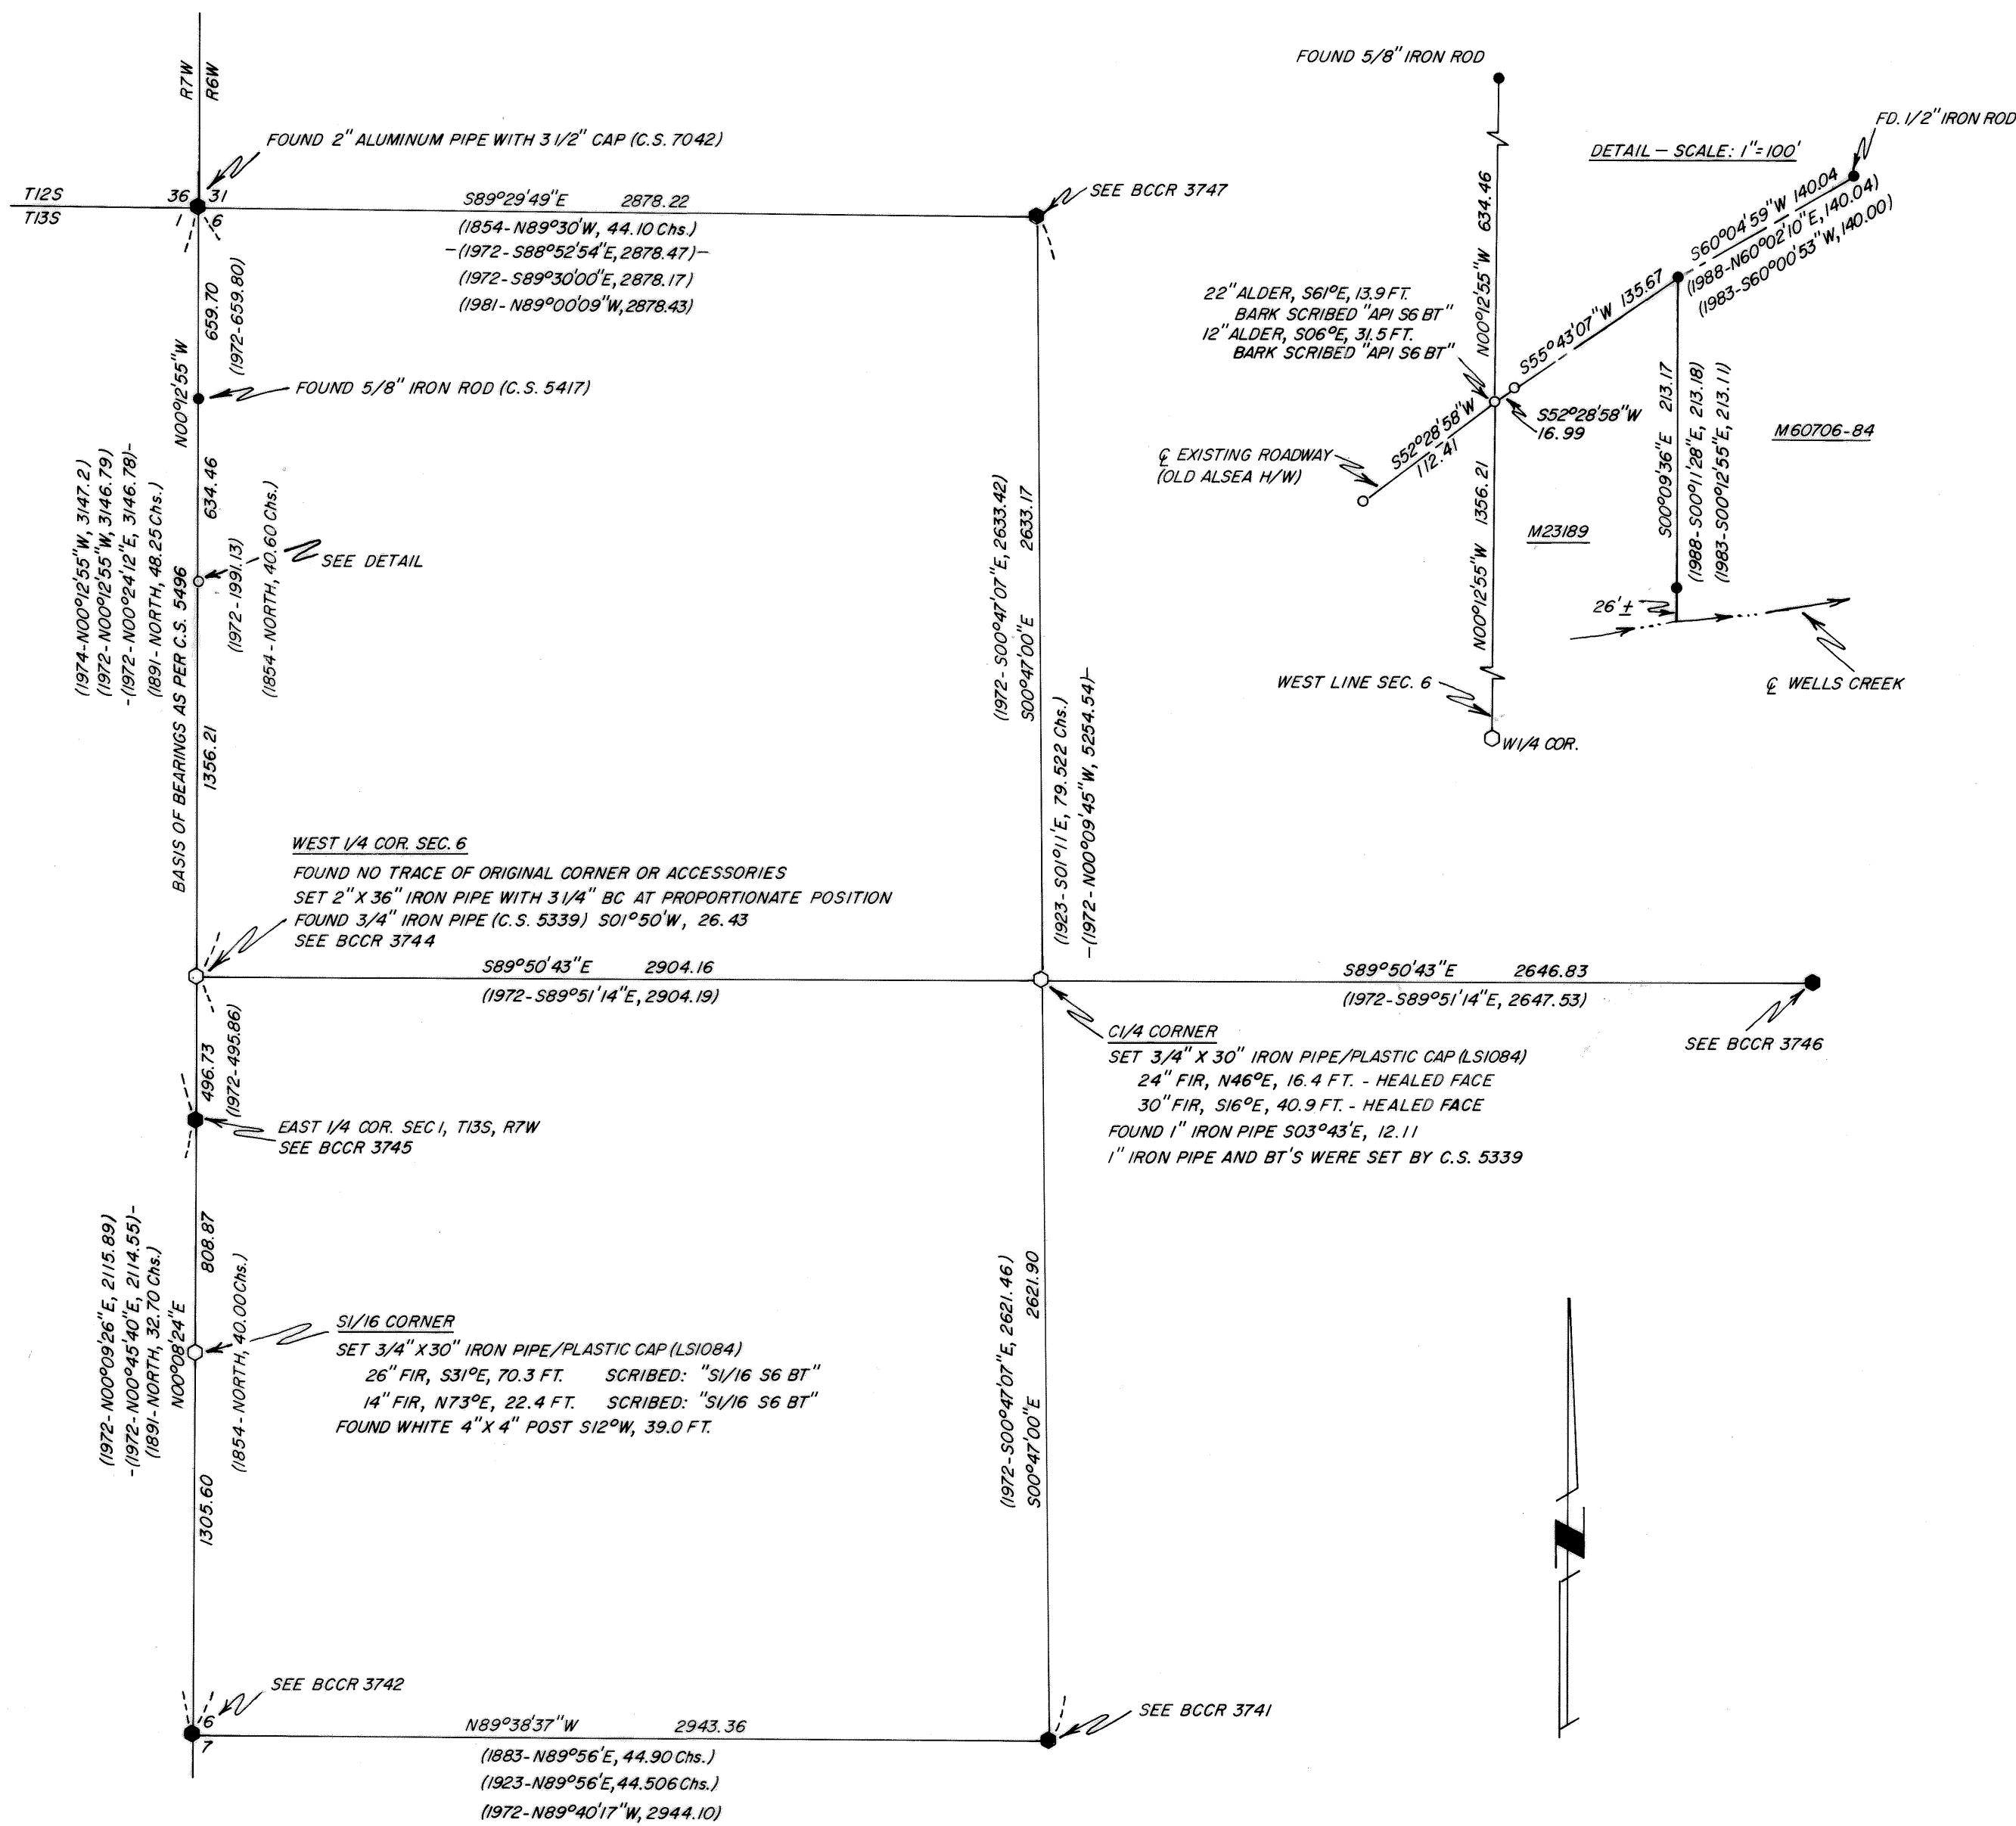
- Found 2" iron pipe with 3/4" brass cap, except as noted
 - Found 5/8" iron rod, except as noted
 - Set 5/8" X 30" iron rod with plastic cap (LS1084)
 - Set monument as noted
 - BC Brass Cap
- (1854) - Data of record as per original survey by Gordon & Preston
 (1883) - Data of record as per original survey by G. Mercer
 (1891) - Data of record as per retracement and original survey by R. Collier
 (1923) - Data of record as per Galloway Hard Copy 13-6-00004
 (1972) - Data of record as per C.S. 5339
 (1972) - Data of record as per C.S. 5496
 (1974) - Data of record as per C.S. 5796
 (1983) - Data of record as per C.S. 7591
 (1988) - Data of record as per C.S. 8121
 Iron pipe diameters are inside measure
 BCCR Benton County Corner Restoration
 AP Angle Point

The purpose of this survey is to reestablish the West 1/4 corner of Section 6, and to set the true center 1/4 corner of Section 6. The SI/16 corner on the West line of Section 6 was also set. Corners were also established as per a metes and bounds description in the NW1/4 of Section 6 (see DETAIL).

In 1972 C.S. 5339 and C.S. 5496 both subdivided Section 6. C.S. 5339 set a pipe for the West 1/4 corner at record distance from a creek as per the 1854 topographic calls. C.S. 5496 computed a position for the 1/4 corner by single proportion. These two positions are approximately 26 feet apart. In order to resolve this problem a letter was sent to the Cadastral Survey Department of the BLM, requesting their opinion as to the correct procedure in this situation. The BLM's response was that topographic calls are rarely used to reestablish original corners, except in cases of extreme distortion or lack of original control corners. Since there is not extreme distortion, and there are original control corners 1/2 mile North and South, we have reestablished the West 1/4 corner of Section 6 by single proportion method. (See copy of letter to the BLM, and their response, attached to this survey.)

At the SW corner of Section 6 we found a 1" iron pipe of unknown origin. C.S. 5339 and C.S. 5496 both call for a wood stake. Starker Forest files contained a reference to an iron pipe, but no mention of its origin. Since this is also a corner of BLM ownership we contacted their State office. Field notes from their administrative surveys note an iron pipe for this corner in 1974. Although no mention was made as to its origin, it is probable that it is an unofficial monument set by the BLM State office during an administrative survey. As the pipe is in correct position with reference to the BT's, and we find no evidence of a wood stake, we have accepted it as a perpetuation of the original corner position.

In 1923 W.C. Galloway did not recover the original 1/4 corner of Sections 6 and 7 (Galloway Hard Copy 13-6-00004). He therefore reestablished said 1/4 corner by proportion. For some reason he did not set the actual corner point, but instead set a witness corner. In 1965 L.J. Martin set a pipe for the 1/4 corner at supposed record bearing and distance from Galloway's recovered witness corner. The correct procedure to establish the 1/4 corner would have been to proportion between Galloway's witness corner and the SW corner of Section 6. This procedure would place the 1/4 corner approximately 18 feet from the iron pipe. But due to the decayed condition of Galloway's witness corner (a large stone) and the extensive use of Martin's pipe we have accepted the pipe as the true corner position.

C.S. 5496 shows the bearing of the W1/2 of the South line of Section 6 to be N89°40'17"E. Computing around that survey shows the bearing to actually be S89°40'17"E.
