RECORD OF SURVEY

STARKER FORESTS, INC.
for **STARKER PROPERTIES, LLC**
DOUGLAS D. THURBER

in SECTION 36, T11S, R7W, W.M.
BENTON COUNTY, OREGON
MARCH 6, 2001

C.S. FILE NO. 10368
FILING DATE 4-23-09
FILE SIZE 18x24

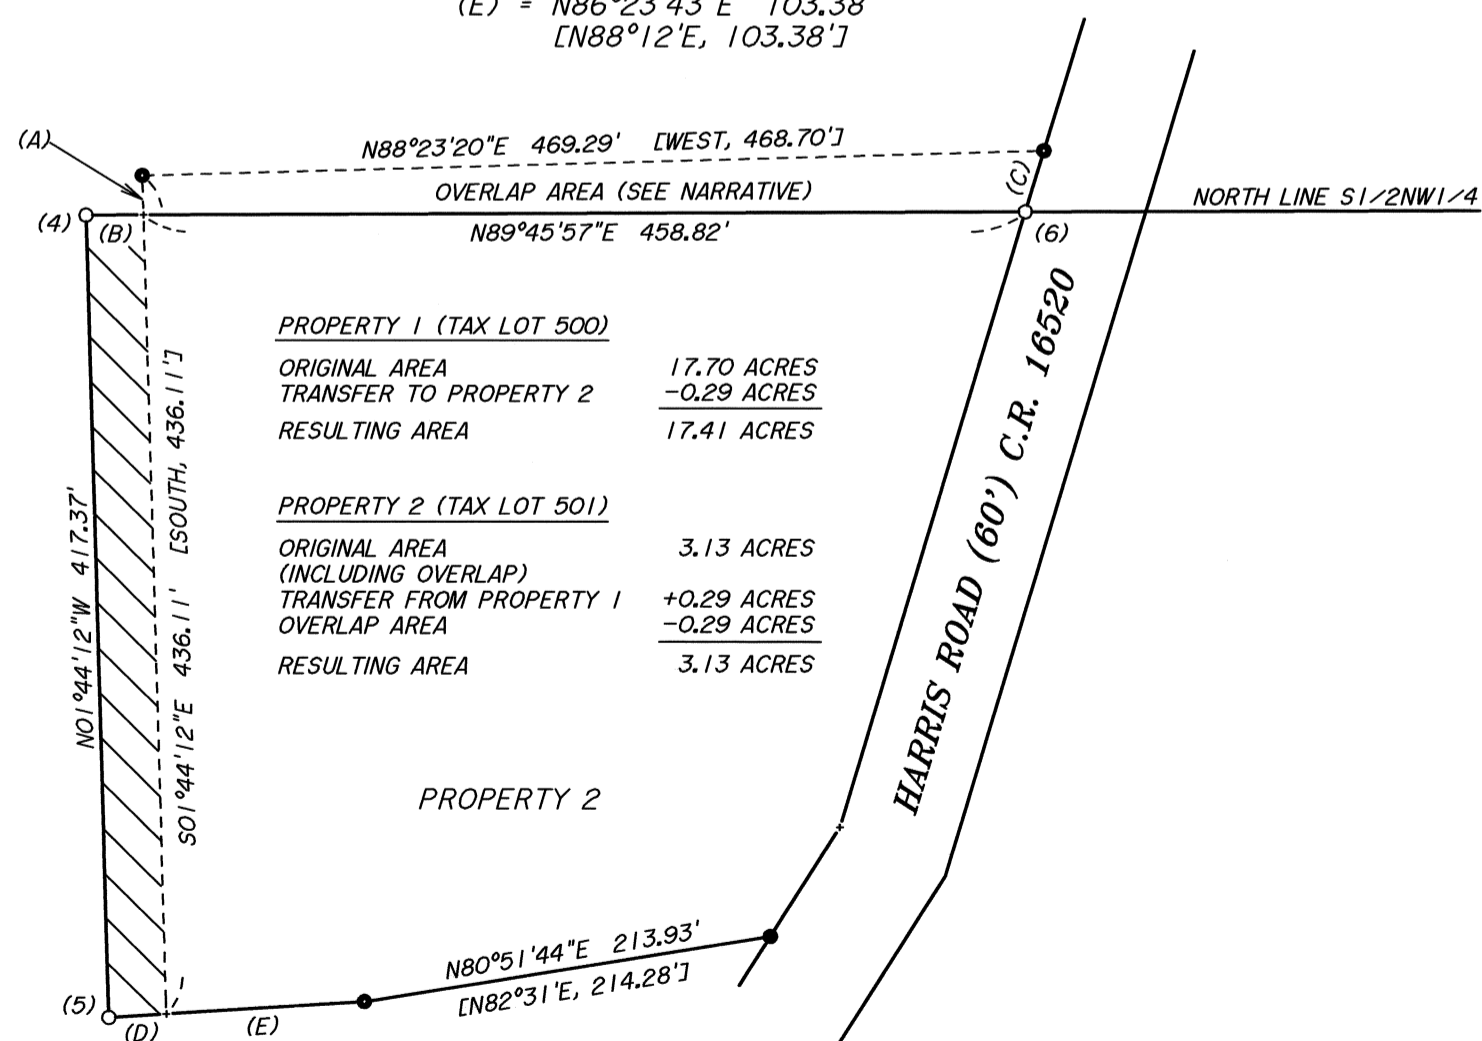
DETAIL (SCALE: 1" = 100')

- (A) = N01°44'12"W 20.50'
- (B) = N89°45'57"E 30.00'
- (C) = N16°54'20"E 33.25'
- (D) = N86°23'43"E 30.01'
- (E) = N86°23'43"E 103.38'
- [N88°12'E, 103.38']

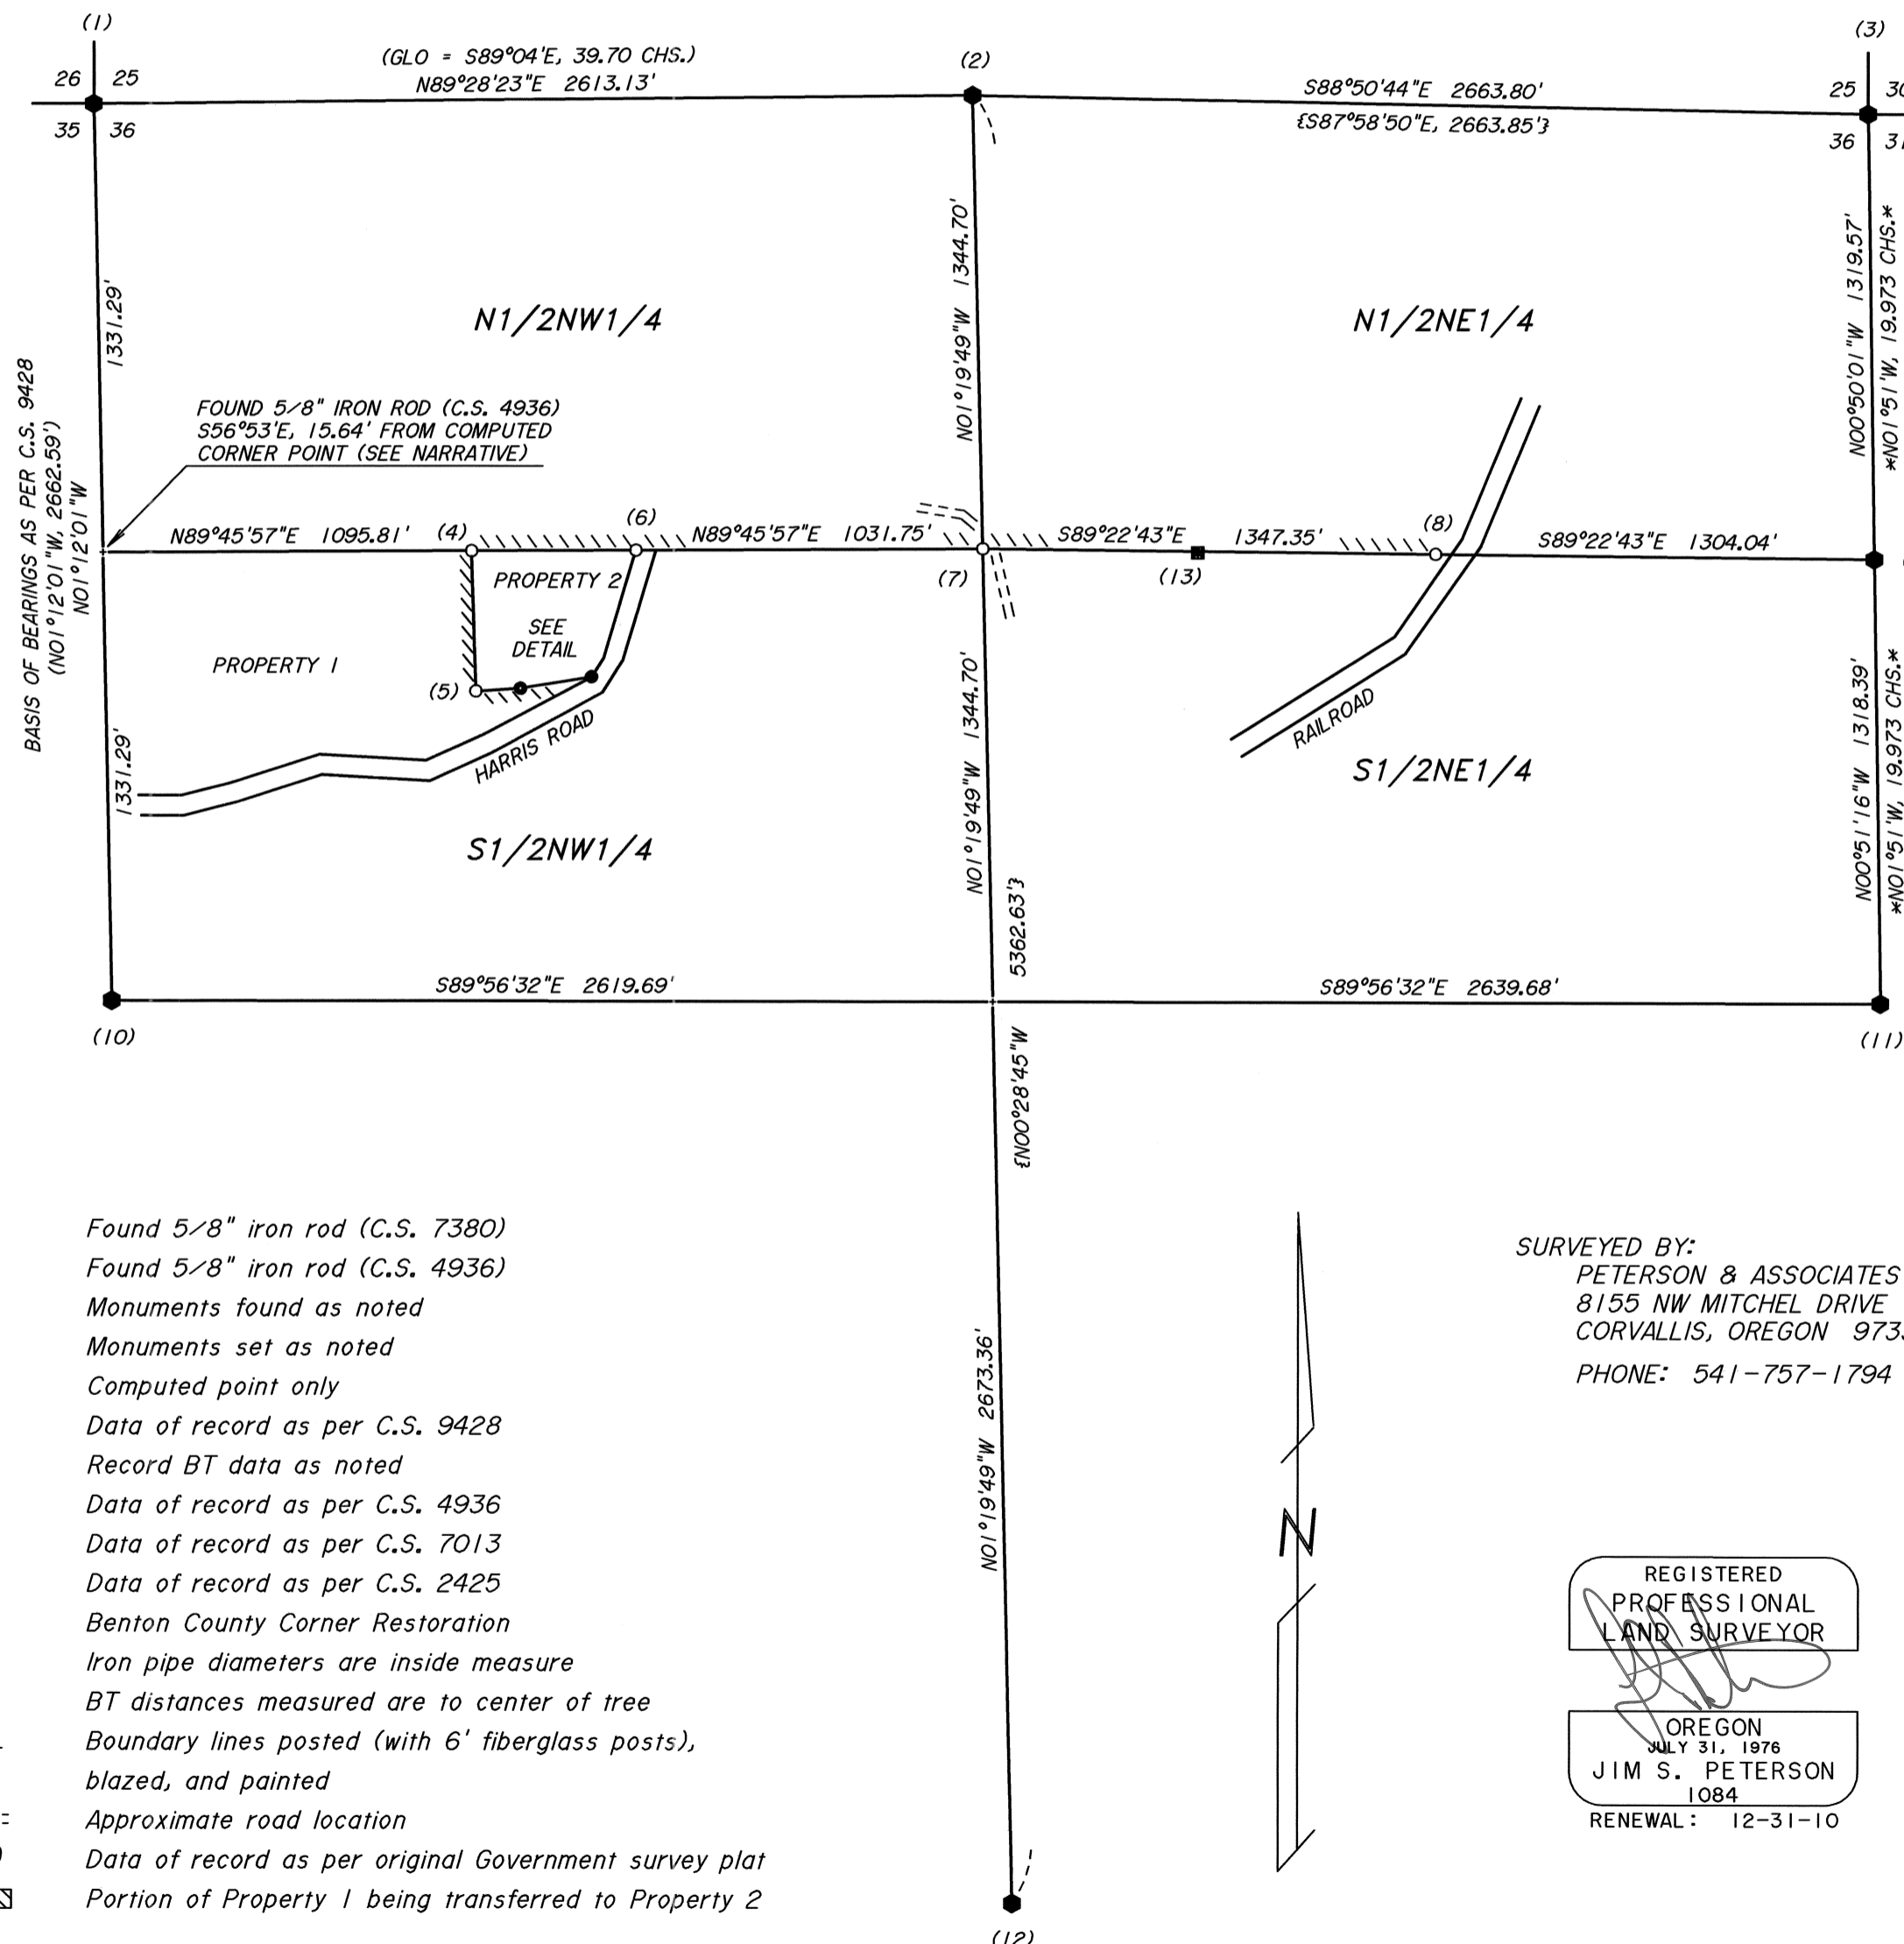
The purpose of this survey is to monument and mark portions of the East-West centerline of the NW1/4 and the NE1/4 of Section 36. We also performed a boundary line clarification and adjustment involving Tax Lots 500 (Starker Properties, LLC) and 501 (Thurber) of Tax map 11-7-36 as per Benton County Development Department File No. LD-01-10.

C.S. 7013 subdivided Section 36 in 1979 using an erroneous corner point for the 1/4 corner between Sections 35 and 36. The true corner point was recovered by C.S. 9428 and held as control for our subdivision of Section 36. Monuments set along the East-West centerline of the NE1/4 of Section 36 by C.S. 7013 and C.S. 7380 were therefore found to be off line as noted.

M-21531, M-77218, M-276470-99, and M-290620-00 of the Benton County Deed Records transfer a tract of land (Tax Lot 501 of Tax Map 11-7-36) based upon C.S. 4936. This tract is also Property 2 of the above noted property line adjustment. C.S. 4936 established erroneous positions for the 1/4 corner and N1/16 corner of Sections 35 and 36 (as noted on this survey and C.S. 9428), and then proceeded to establish boundaries as called in the above noted deeds. Said deeds call for the North line of Tax Lot 501 to be along the North line of the SW1/4NW1/4 of Section 36, and also calls for monuments and dimensions as per C.S. 4936. C.S. 4936 did not subdivide Section 36, used erroneous corners on the West line of Section 36, and does not directly call for the North line of the SW1/4NW1/4 as the deeds do. We find that the monuments called along the North line of the above noted deeds are actually North of the Section subdivision line, and therefore create an overlap with the property to the North (owned by Starker Forests). In order to correct this overlap Property 1 will transfer an area to Property 2 equal in size to the above noted overlap. This will be done in exchange for an agreement by the owner of Property 2 to relinquish any rights he may have to land North of the North line of the SW1/4NW1/4, or otherwise outside of the boundaries of Property 2 as surveyed by C.S. 4936.

Monuments found as per BCCR 1101, BCCR 1102, BCCR 116100200R1, BCCR 1159, C.S. 2425, C.S. 7013, and Old Corner Restoration Book 1, Page 214 were held as control for this survey.
