Survey for
Venell Farms Inc. & Chad Cook
Property Line Adjustment Survey for
Venell Farms Inc. & Mark and Linda Cook

in the Albert Rhinehart DLC No. 73
 Section 21 and E1/2 Section 22, T12S, R5W, W.M.
 Benton County, Oregon
 May 25, 2017
 Benton County File No. LU-17-030

CS FILE NO. 10844
 FILING DATE 9-8-17
 FILE SIZE 18x24

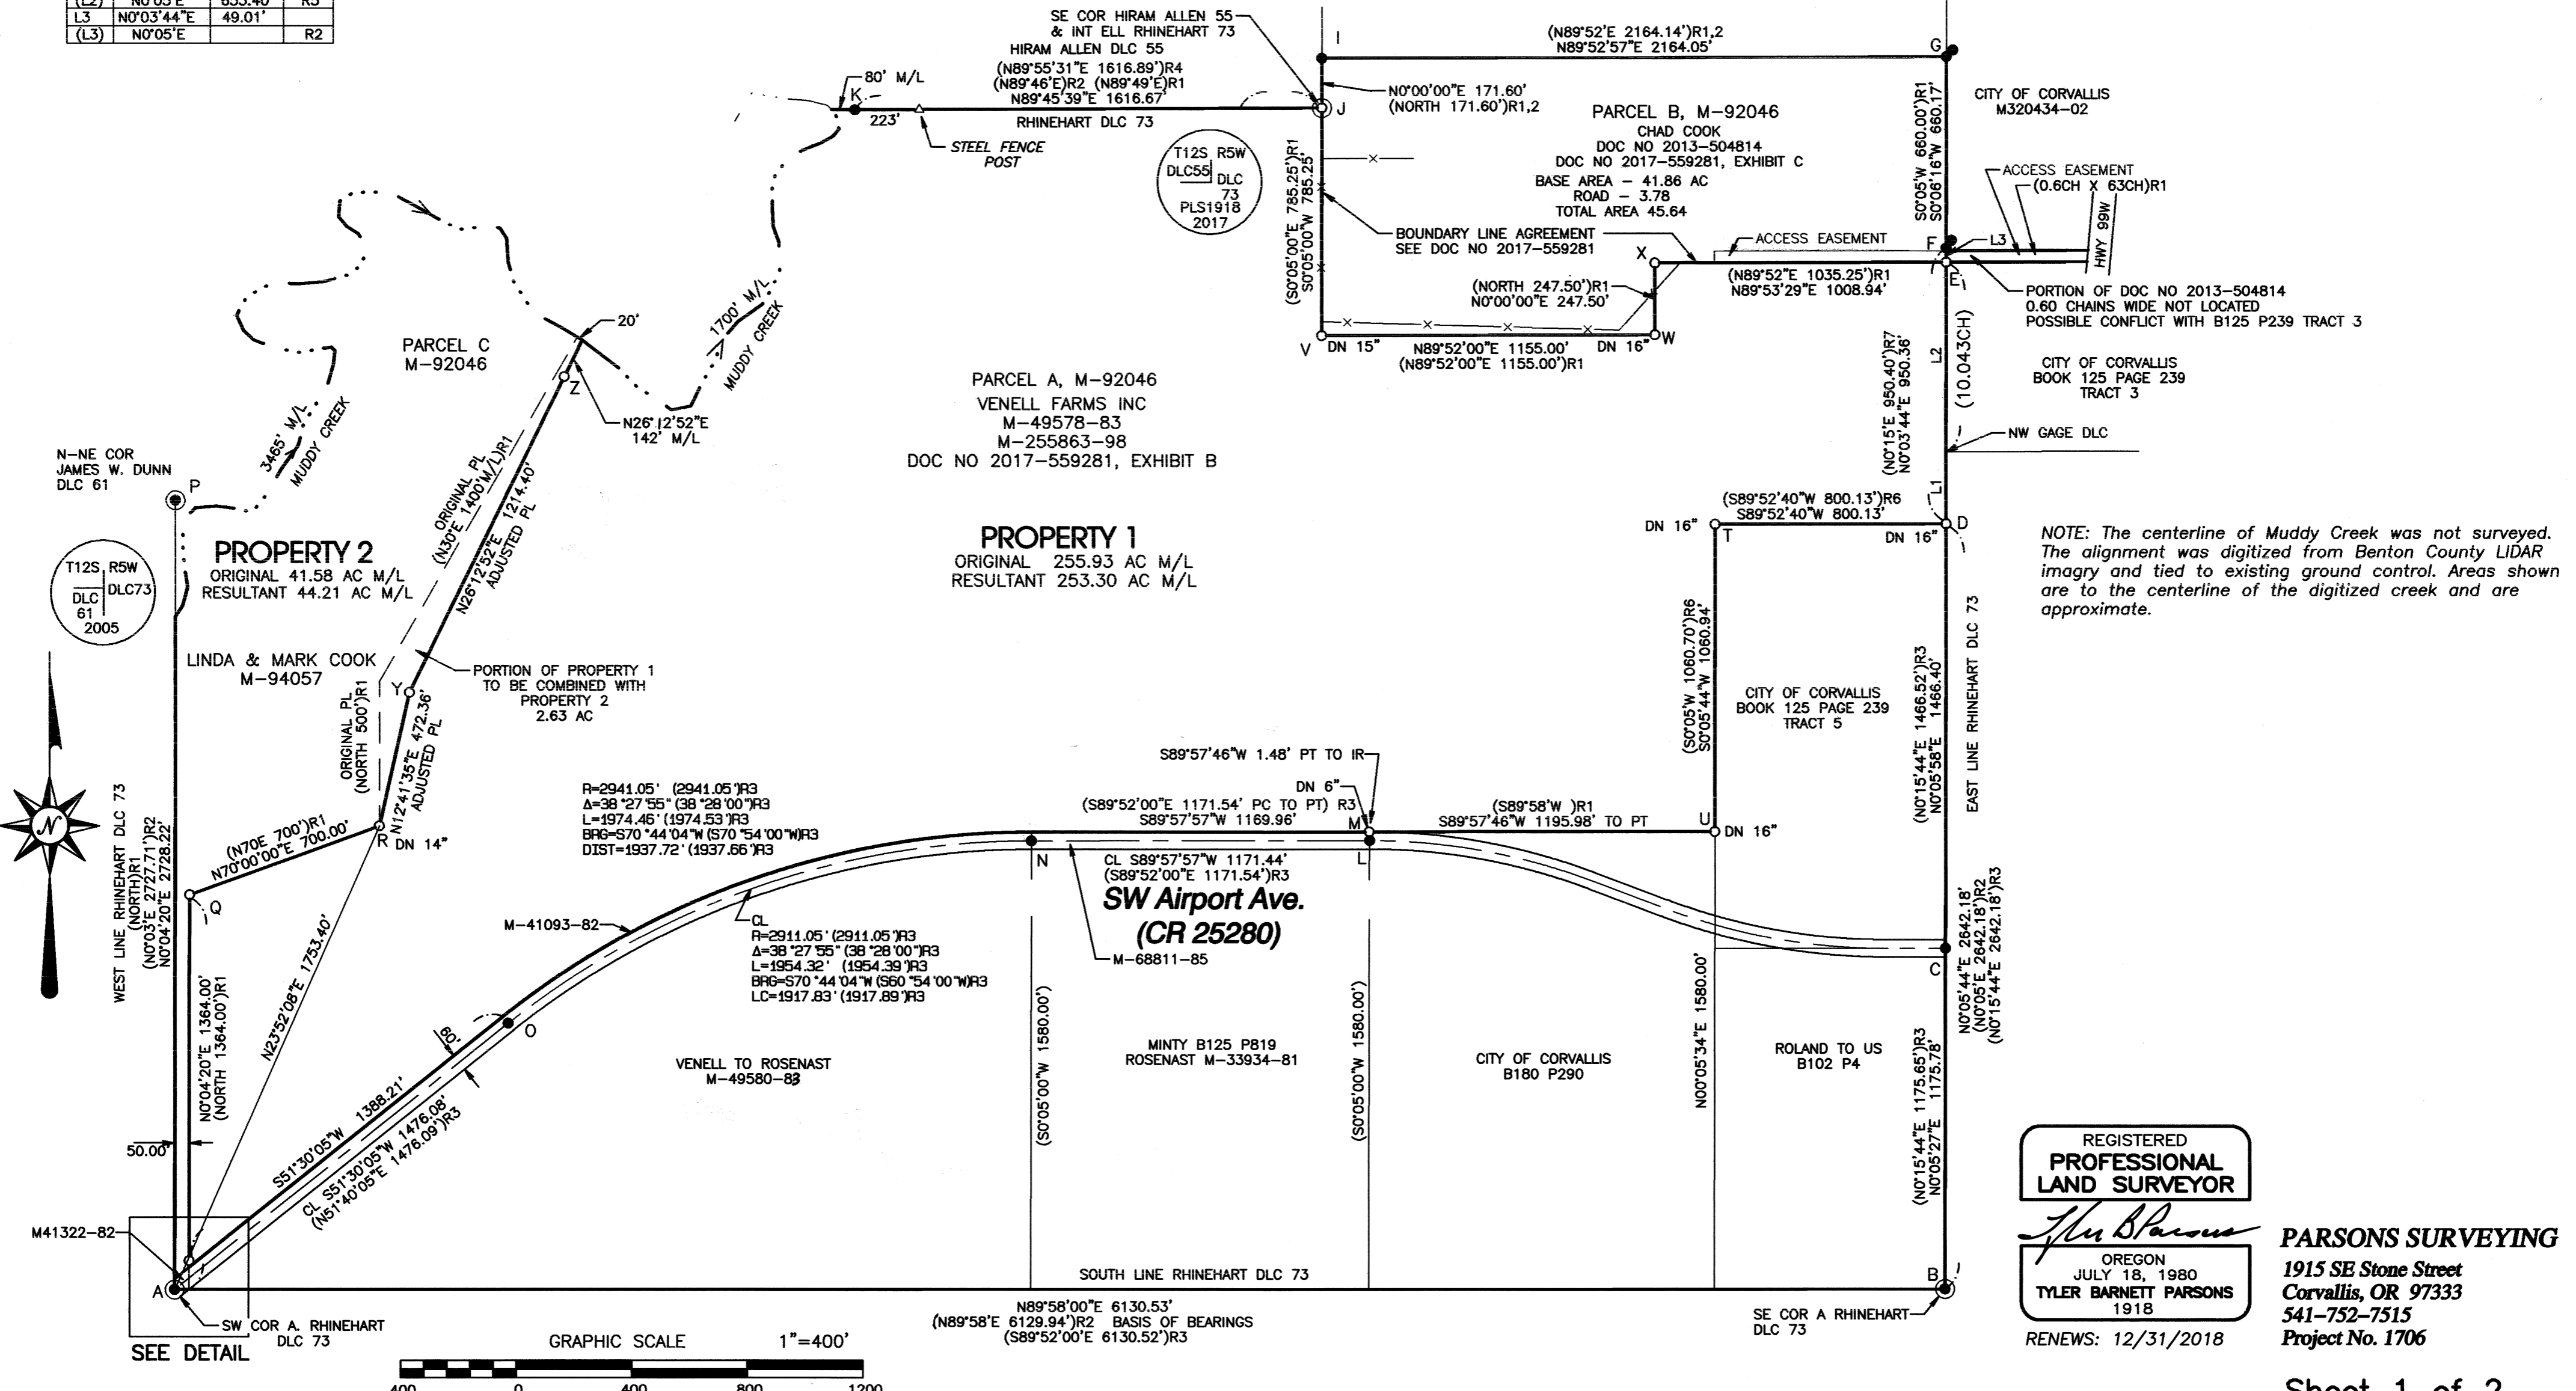
NOTE: The centerline of Muddy Creek was not surveyed. The alignment was digitized from Benton County LIDAR imagery and tied to existing ground control. Areas shown are to the centerline of the digitized creek and are approximate.

Basis of Bearings is the south line of the Rhinehart DLC 73 between southwest corner at A and the southeast corner at B, North 89°58'00" East per Galloway Hard Copy (GHC) 12500040. The descriptions contained in M-92046 appear to have been written with respect to this survey. Survey was conducted using a combination of static GPS control with total station ties to found monuments.

I reestablished northeast corner Tract 5, Book 125 Page 239, which is also a corner of Parcel A by holding the record angle at B from A to D of 90°07'44" per CS 7567, a survey by Benton County of the new alignment of Airport Avenue and the last survey of record showing the location of the 1-1/4" pipe. The CS 7567 angle at B and distance to D matches previous records extremely well. I did not hold the monument at H as it appears it was record from D, the found monuments at F and G fit the record in GHC 12500040 and GHC 12500041 very well with only a few tenths of a foot variance in bearings and distances from the record line between B and G. I set the northeast corner of Parcel A at E on the line between D and F at the deed called distance of 9.90 chains (653.40') north of the calculated northwest corner of the Gage Claim. A few feet northeast of F, I found a 5/8" iron rod set in CS 9714 as a remonumentation of the radius rod shown in GHC 12500041, but which I found to be about 3.5 feet north and 2.2 feet east of the record corner position. This iron rod was used to reestablish the northeast corner of the Rhinehart Claim at H using record distance (18.30 chains) north and at record distance from an Osage Orange tree. CS 9714 also found the stone at G but rejected it as "disturbed" and set a replacement corner for that corner. I found the stone about 2 feet south of the fence corner noted in GHC 12500037. The stone appeared to be undisturbed, buried about 3", of the approximate size noted in the field notes (2"x10"x?), and I accepted it as the northeast corner of Parcel B and on the DLC line. My measured distance from G to H is shown.

I found none of the northerly right of way monuments of Airport Avenue shown in CS 7453 and 7567 along the south line of the Venell property. I calculated the position of the right-of-way PCs and PTs on the north line at right angles to the centerline tangents. I reestablished the corner at T at record distance and direction from D per the description of Tract 5, Book 125 Page 239, and the corner at U, S0°15'55"W parallel with the line B-D and at 1580 feet northerly of the south line of DLC 73, as per deed. I accepted the position of the northwest corner of Book 180 Page 290 at M, the intersection of the south line of Parcel A with the north right-of-way line of Airport Avenue as shown in Detail "C" of CS 7453 and set the corner monument on the right-of-way line S89°57'46"W 1.48 feet from the calculated PT.

- B - Found a 1-1/4" iron pipe in monument box, down 16", restoration 125873020, the southeast corner DLC 73.
- C - Found a 5/8" iron rod, with Benton County Surveyor yellow plastic cap, in monument box. See CS 7453.

- D - Searched, not found. Set a 5/8" iron rod down 16" - see narrative.
- E - Set a 5/8" iron rod, 9.90 chains northerly from calculated position of the NW corner Gage DLC.

- A 5/8" iron rod bears N39°56'15"E 10.53', down 6", unknown origin.
 - A guy anchor bears S57°34'W 2.14 feet, down 6"
- F - Found a broken wishbone of Ford, R2, the remaining 1/2" pipe portion vertical in the ground.

- A 5/8" iron rod with red plastic cap marked NORTHSTAR PLS1932 bears N34°04'42"E 4.18', down 6", set in place of a radius rod, R4.
- G - Found a stone, 2"x8"x?, down 3", firmly set, per R2. I cut an "X" in the center top.

- A fence corner post bears S40°E 2.2'
 - A 5/8" iron rod, with red plastic cap marked NORTHSTAR PLS1823 bears N28°49'E 3.76 feet, R4.
- H - Found a 3-1/4" Benton County brass disk set for northeast corner DLC 73, R4 & Restoration 125873010. See Narrative.

- I - Found a 3/4" iron pipe, down 10", R2
- J - Searched 5/8" iron rod, R4, not found. I reestablished this corner S0°00'00"E 171.60 feet (2.60 chains) from I, Set a 2-1/2" aluminum cap with magnet on a 2" x 30" aluminum pipe with flared bottom 29" in the ground with a concrete collar, from which:

- K - Found a 5/8" iron rod RPC "NORTHSTAR PLS1823" on south line Allen DLC 55, R4.
- L - Found a 5/8" iron rod with Benton County Surveyor yellow plastic cap centerline monument in monument box, R3.
