RECORD OF SURVEY  
FOR  
**DALE HUNNICUTT**  
IN THE  
SE 1/4 OF SECTION 31 &  
SW 1/4 OF SECTION 32  
T 14 S, R 5 W, W.M.  
BENTON COUNTY, OREGON

BENTON COUNTY  
SURVEYOR'S OFFICE  
C.S. FILE NO. 10897  
FILING DATE 5-16-18  
FILE SIZE 18x24

MAY 4, 2018

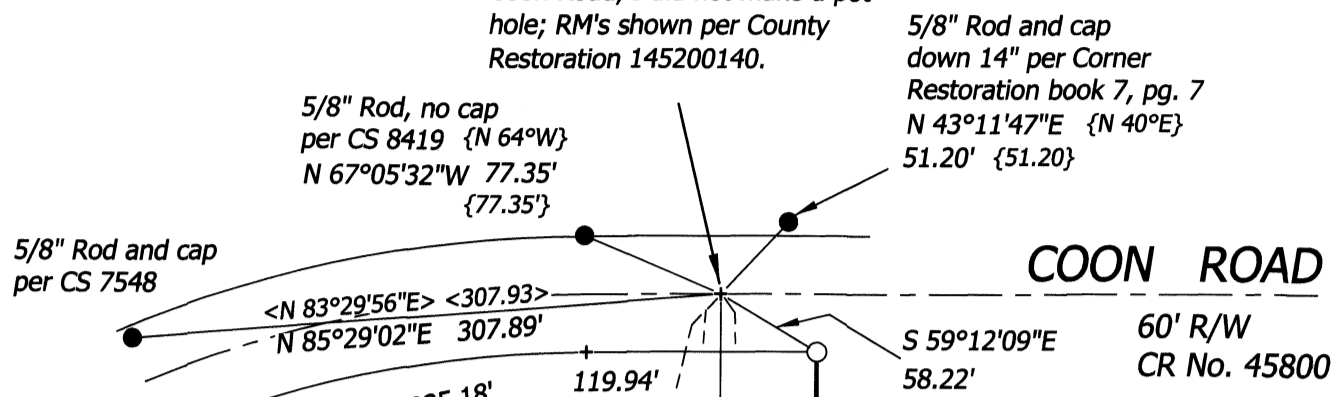
**1/4 CORNER SEC. 31 & 32**

Monument lies under pavement of  
Coon Road, I did not make a pot  
hole; RM's shown per County  
Restoration 145200140.

I decided to not disturb the monument at the 1/4 corner because Coon Road is a high speed County Road and the pot hole would have been 1.5 feet south of the painted centerline. I located 2 of the reference monuments and calculated the corner position as shown from the measurements from the County Surveyor's restoration. This fit nicely to the distance to the Devco monument from CS 7548 found in the north right-of-way to the west.
